WATER QUALITY UPDATE

August 28, 2014

Melinda Friedman, Confluence Engineering Group, LLC

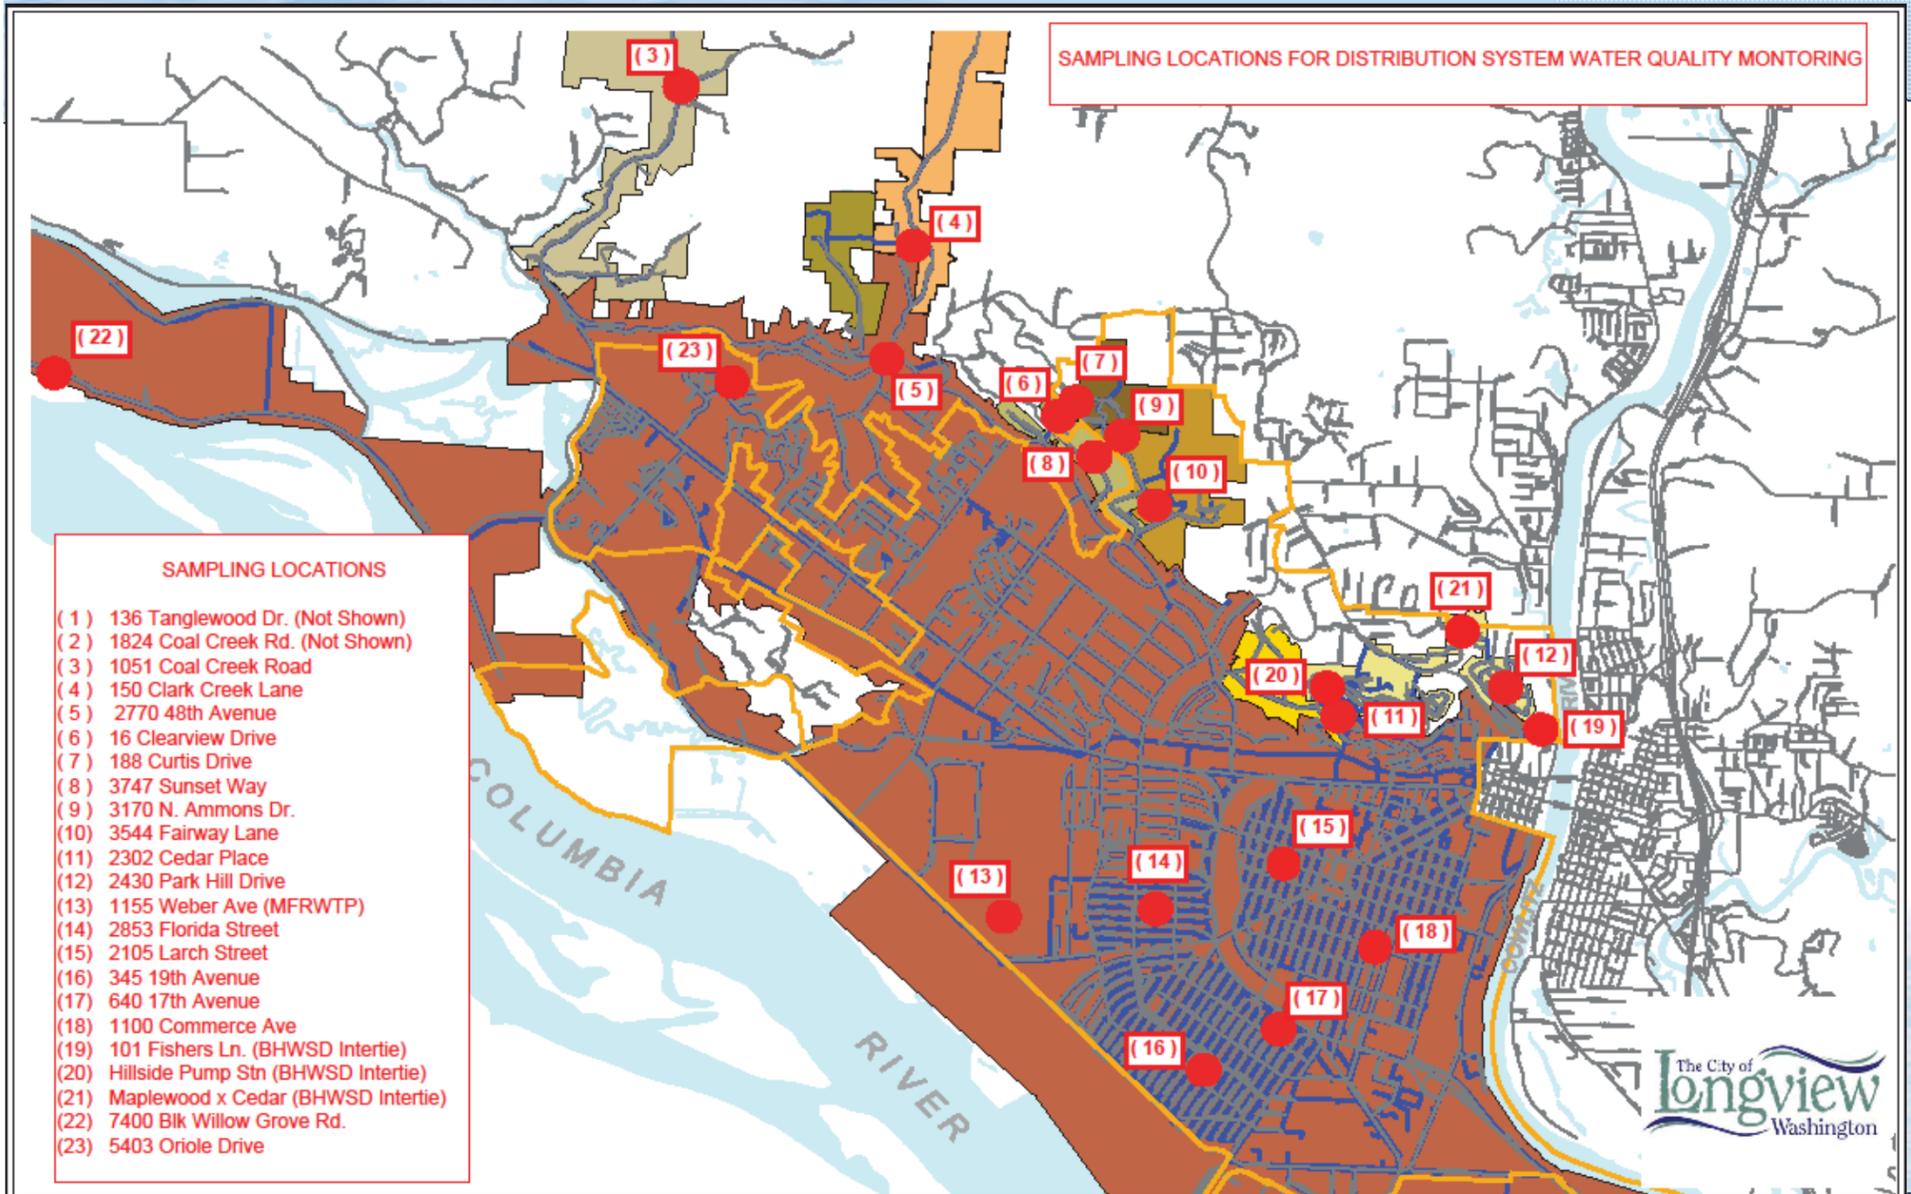
Distribution System Water Quality Testing Sites

- ▶ **Ongoing distribution system sampling at 9 sites**
 - **Obtained one year of detailed data to diagnose issues and determine controlling factors**
 - **Sampling program scaled back in July 2014**
 - **Continuing monitoring to track conditions and identify changes**
- ▶ **Distribution system continues to improve**
 - **Acceptable chlorine level at all areas except Site 17**
 - **Acceptable iron level at all areas except Site 17**
 - **Acceptable manganese levels at all areas**

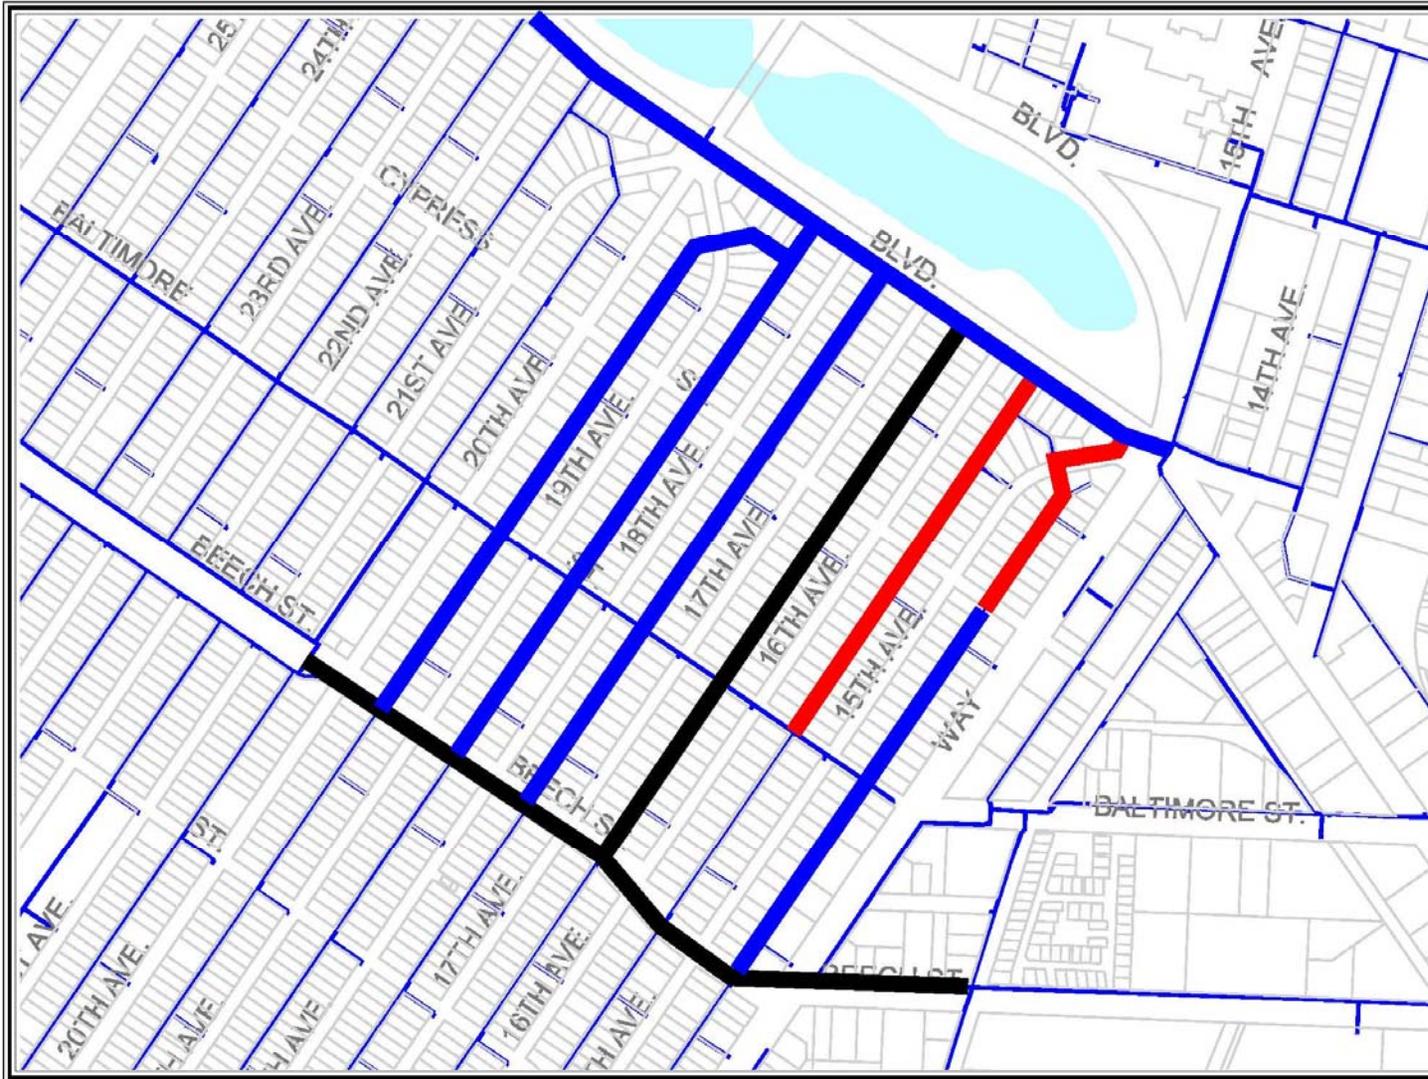
Water Main Replacement Planning

- ▶ Replaced (5,000 LF)
- ▶ In Design (2,500 LF)
- ▶ Future

- ▶ **Enhanced city-wide main replacement program needed to address leaks, undersized pipe, inadequate flow and poor water quality**
- ▶ **High priority given to water quality**
- ▶ **Expanded water quality monitoring in Baltimore Area to identify extent and degree of issues after emergency main replacement**
- ▶ **Topographic surveys completed for several alleys**
- ▶ **Design 30% complete for selected main replacement**

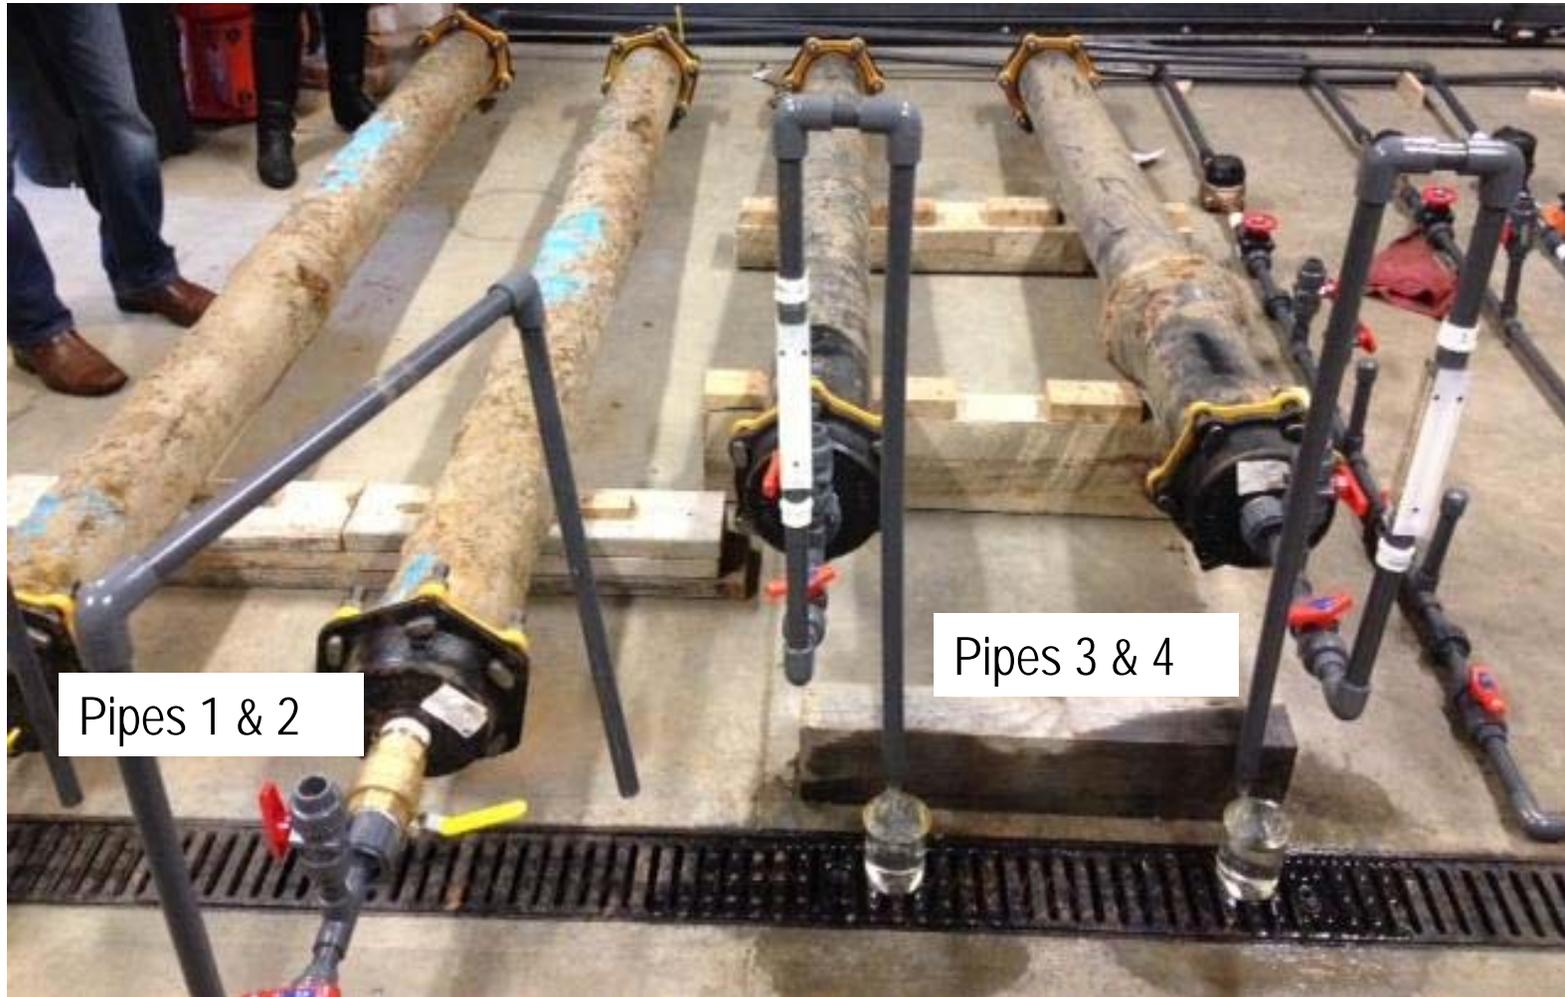
Dissolved Oxygen Trials - Pipe Rigs

- ▶ **Used pipe rigs to assess impact of increased DO levels on water quality**
 - **Assembled from existing pipes removed from the system**
 - **Ocean Beach Hwy (Pipes 1 and 2)**
 - **Alley between 16th and 17th (Pipes 3 and 4)**
- ▶ **Conditions Studied**
 - **Low DO - Did not modify current DO levels in treated water (< 1 mg/L); tested in Pipes 2 and 3**
 - **Moderate DO - Injected moderate levels of DO into treated water (5-7 mg/L); tested in Pipes 1 and 4**
 - **Different stagnation times were studied (0 – 48 hours)**

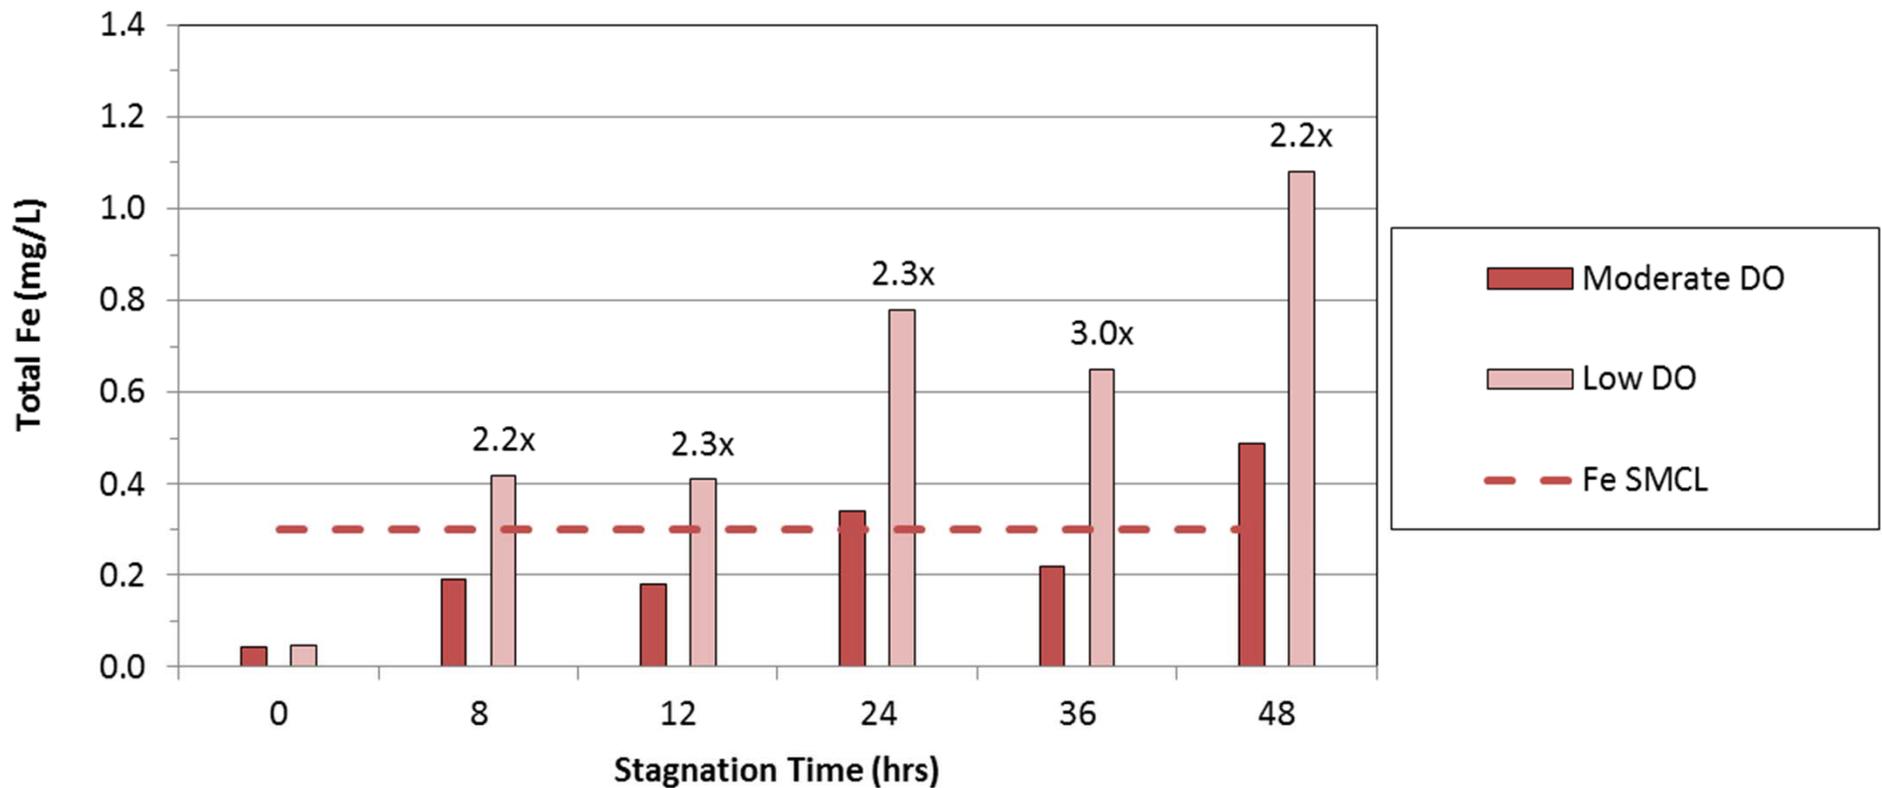
Dissolved Oxygen Trials - Iron Comparison

Moderate vs Low DO: End of Stagnation Total Fe

- ▶ **Moderate levels of DO:**
 - **Significantly improve aesthetic water quality conditions**
 - Iron
 - Manganese
 - Apparent Color
 - **Help to meet SMCLs for longer period of stagnation time**
 - **Reduces dependency on maintaining specific chlorine residual**
 - **Does not appear to affect rate of chlorine decay**
 - **Multiple constituents in pipe scales impacting decay rate**
 - **Benefit of DO injection on chlorine decay rate may improve over time**

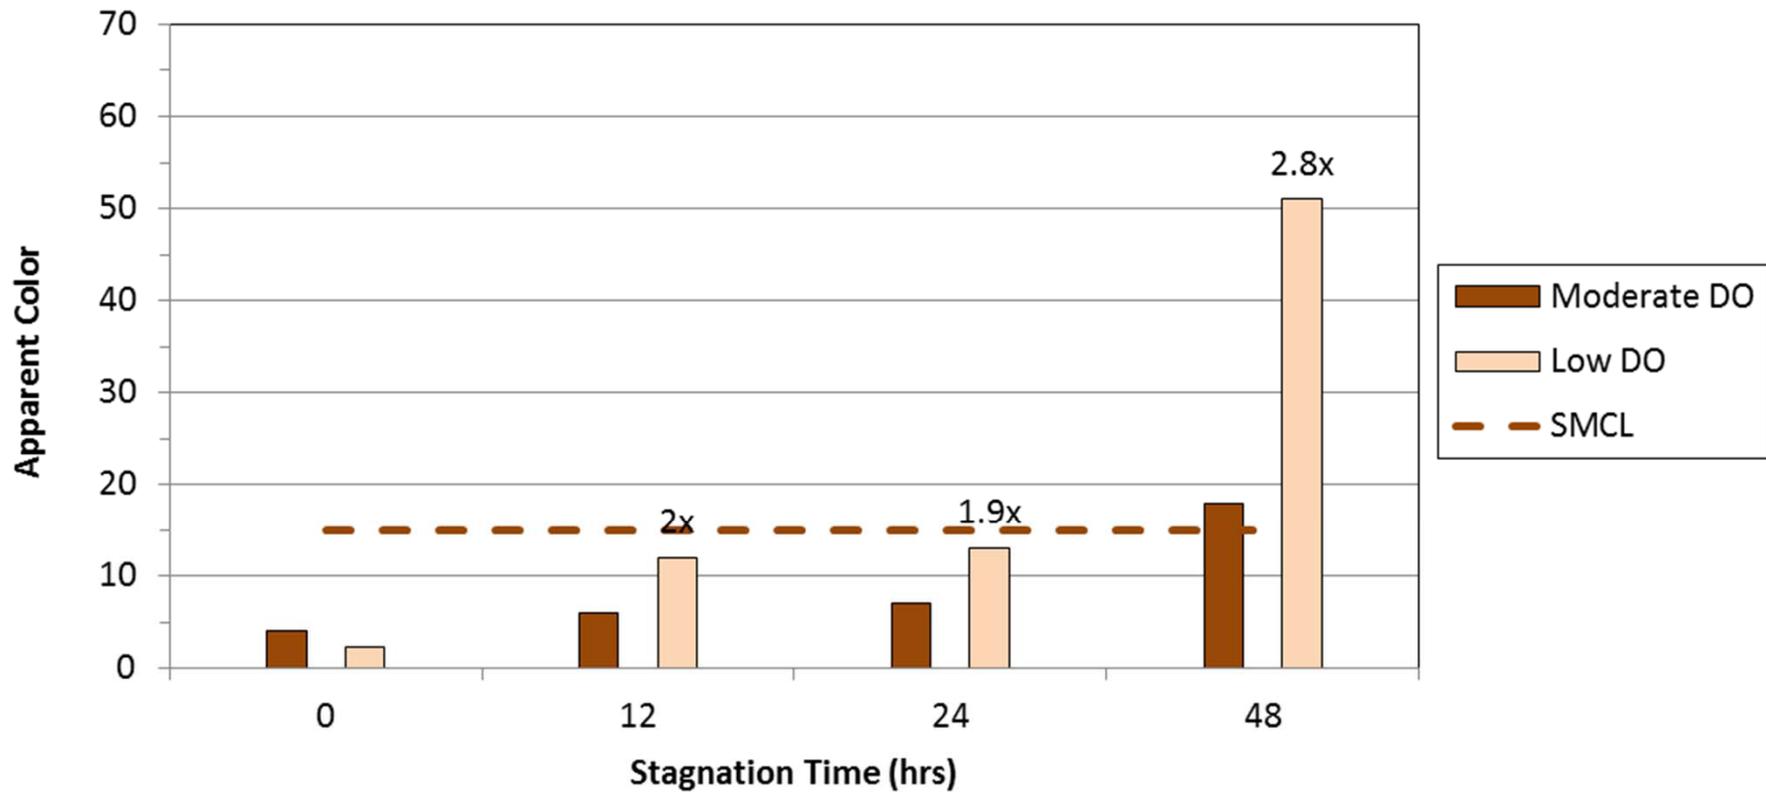
Dissolved Oxygen Trials - Color Comparison

Moderate vs Low DO: End of Stagnation Apparent Color

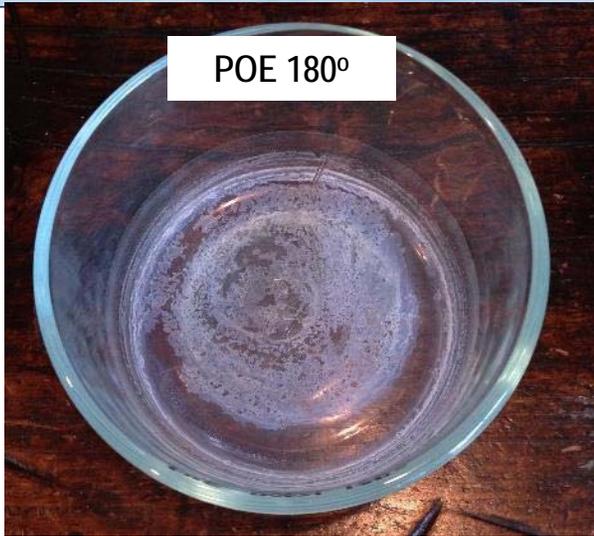
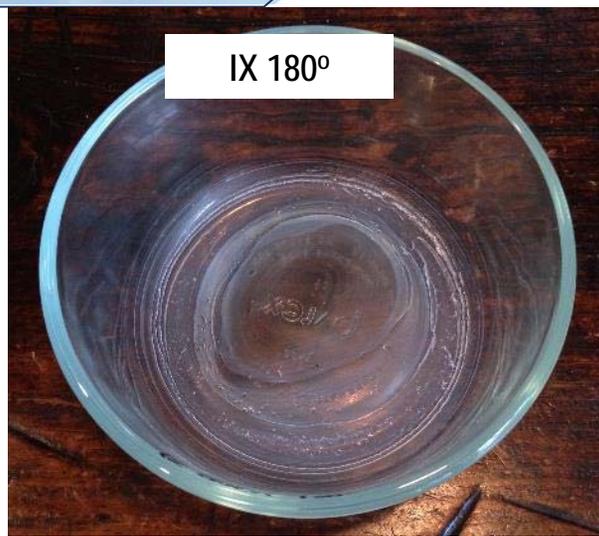
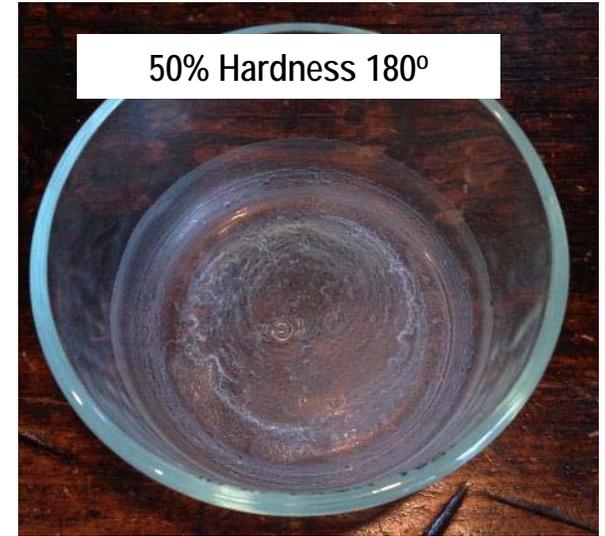
Silica Evaporation Trials

- ▶ **Additional softening trials conducted to:**
 - Confirm visual appearance using larger volumes of water (100 mL versus 0.1 mL on tiles)
 - Assess impact of softening on ease of cleaning
 - Silica levels remained constant in all tested waters
- ▶ **Three waters prepared, evaporated, and cleaned:**
 - Point of Entry water (POE)
 - Ion Exchange water (IX)
 - 100% hardness removed
 - Representative of what a homeowner could install
 - 50% Softened
 - Representative of a pellet softening system at the treatment plant

100 mL in an 180°F Oven

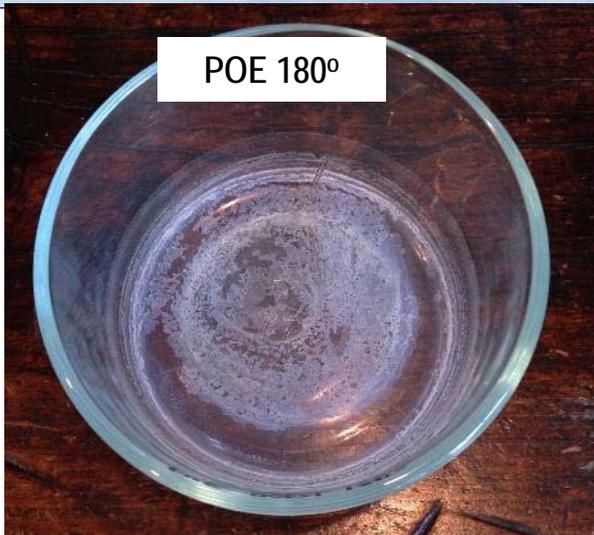
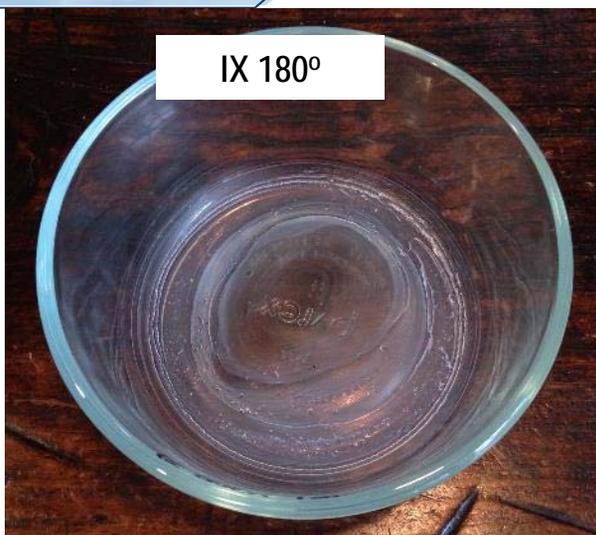
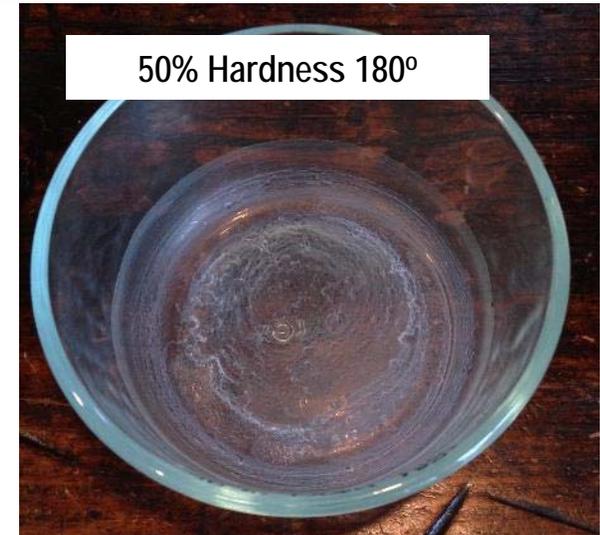
Silica Evaporation Trials

- ▶ **Testing on stainless steel cookware and pans yielded evaporation and cleaning results similar to glass cookware**

100 mL in an 180°F Oven

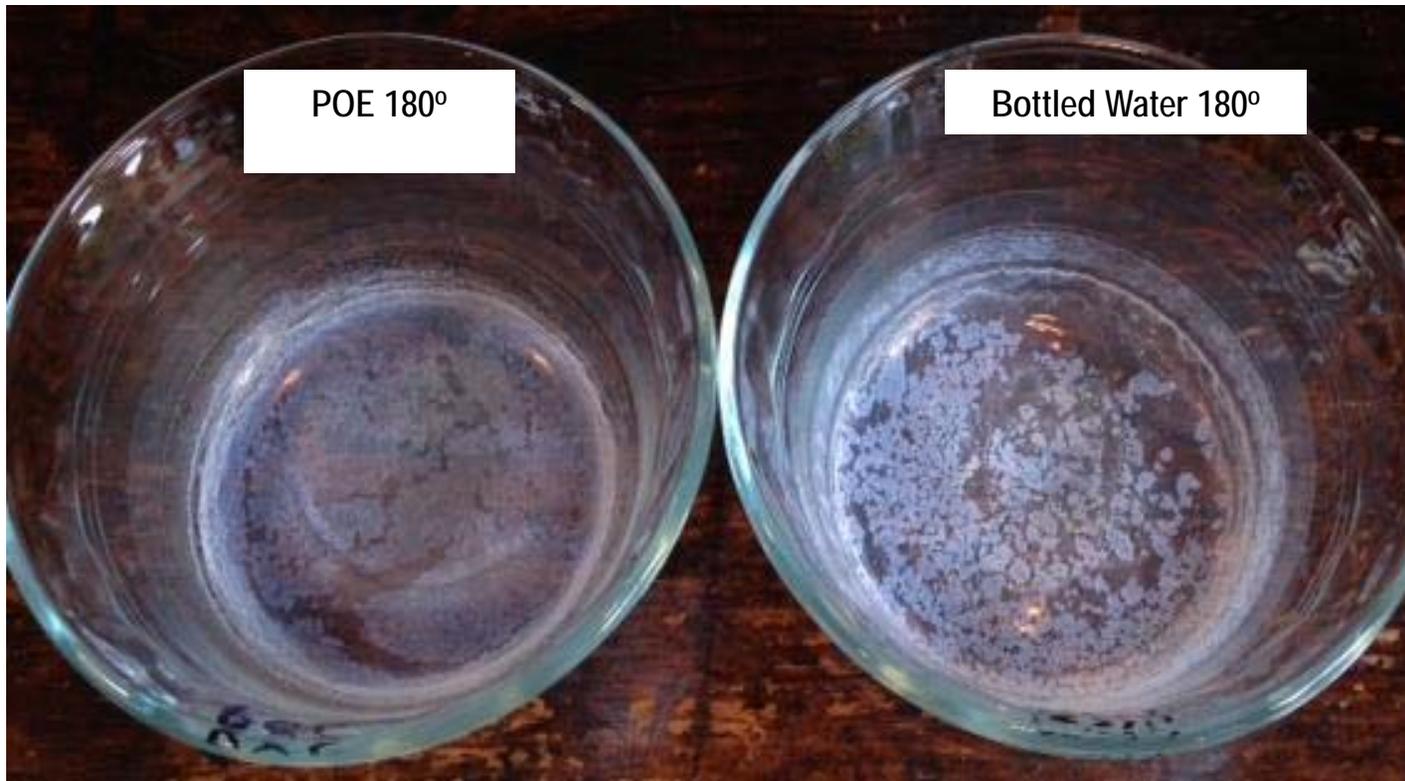
Silica Evaporation Trials

- ▶ Both contain naturally occurring minerals, including moderate hardness and high silica content
- ▶ Assess visual appearance of FDA regulated bottled water (approx. \$7/gal)

Silica		Total Hardness (mg/L CaCO ₃)	Alkalinity (mg/L CaCO ₃)	Total Dissolved Solids (mg/L)
	Total (mg/L SiO ₂)	Dissolved (mg/L SiO ₂)			
Longview Water	54.9	54.2	111	105	222
Bottled Water	84.9	82.6	104	130	224

Comparison of Longview Water to a Retail Bottled Water

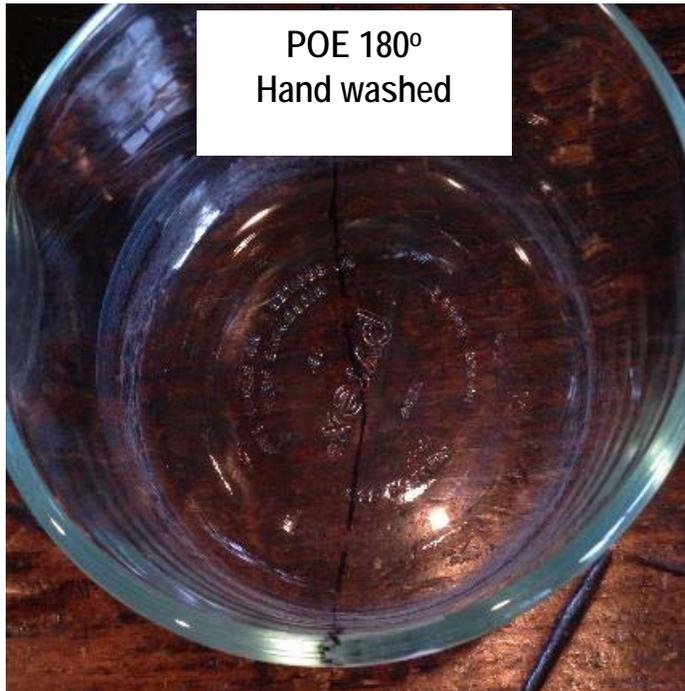
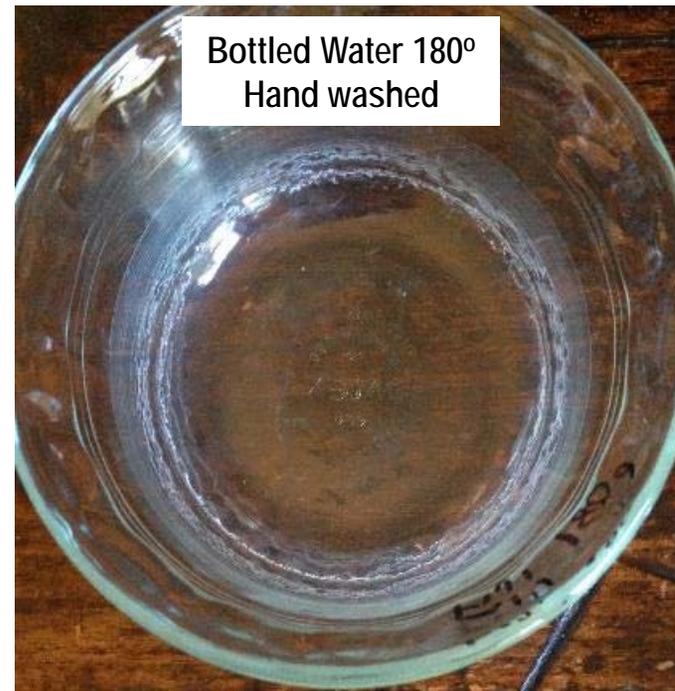
Silica Evaporation Trials

Comparison of Longview Water to a Retail Bottled Water

- ▶ **Primary cause of spotting is naturally-occurring silica**
 - Silica appears to “etch” surfaces if allowed to evaporate
- ▶ **Aesthetic issue not experienced equally by all customers; varies with:**
 - Type and age of glassware/surface
 - Amount of handwashing and hand drying
 - Dishwasher use and settings, detergent type and rinse aids
 - Evaporation plus heat is most problematic
- ▶ **Softening not likely to make significant improvement**
 - No change in visual appearance or ease of cleaning
- ▶ **Longview water and bottled water are both safe to drink**
 - Longview Water meets all EPA and DOH Safe Drinking Water Act regulations
 - Retail bottled Water meets FDA regulations
