Geotechnical Data Report Longview Regional Water Treatment Plant Longview, Washington

June 7, 2010

This Geotechnical Data Report (GDR) presents the results of our field geotechnical investigation and laboratory testing program for the Longview Regional Water Treatment Plant and associated waterline in Longview, Washington. The overall project location is shown on the Vicinity Map, Figure 1. The Site and Exploration Plan, Figure 2, shows the approximate location of the explorations completed for this study as well as the locations of historical borings completed by others along the waterline alignment. Figure 3 presents a Site and Exploration Plan for the Water Treatment Plant Site. Appendix A presents summary logs of conditions observed in the explorations completed for this study. The results of the laboratory testing program are included as Appendix B. Logs of previous explorations completed by others are included in Appendix C.

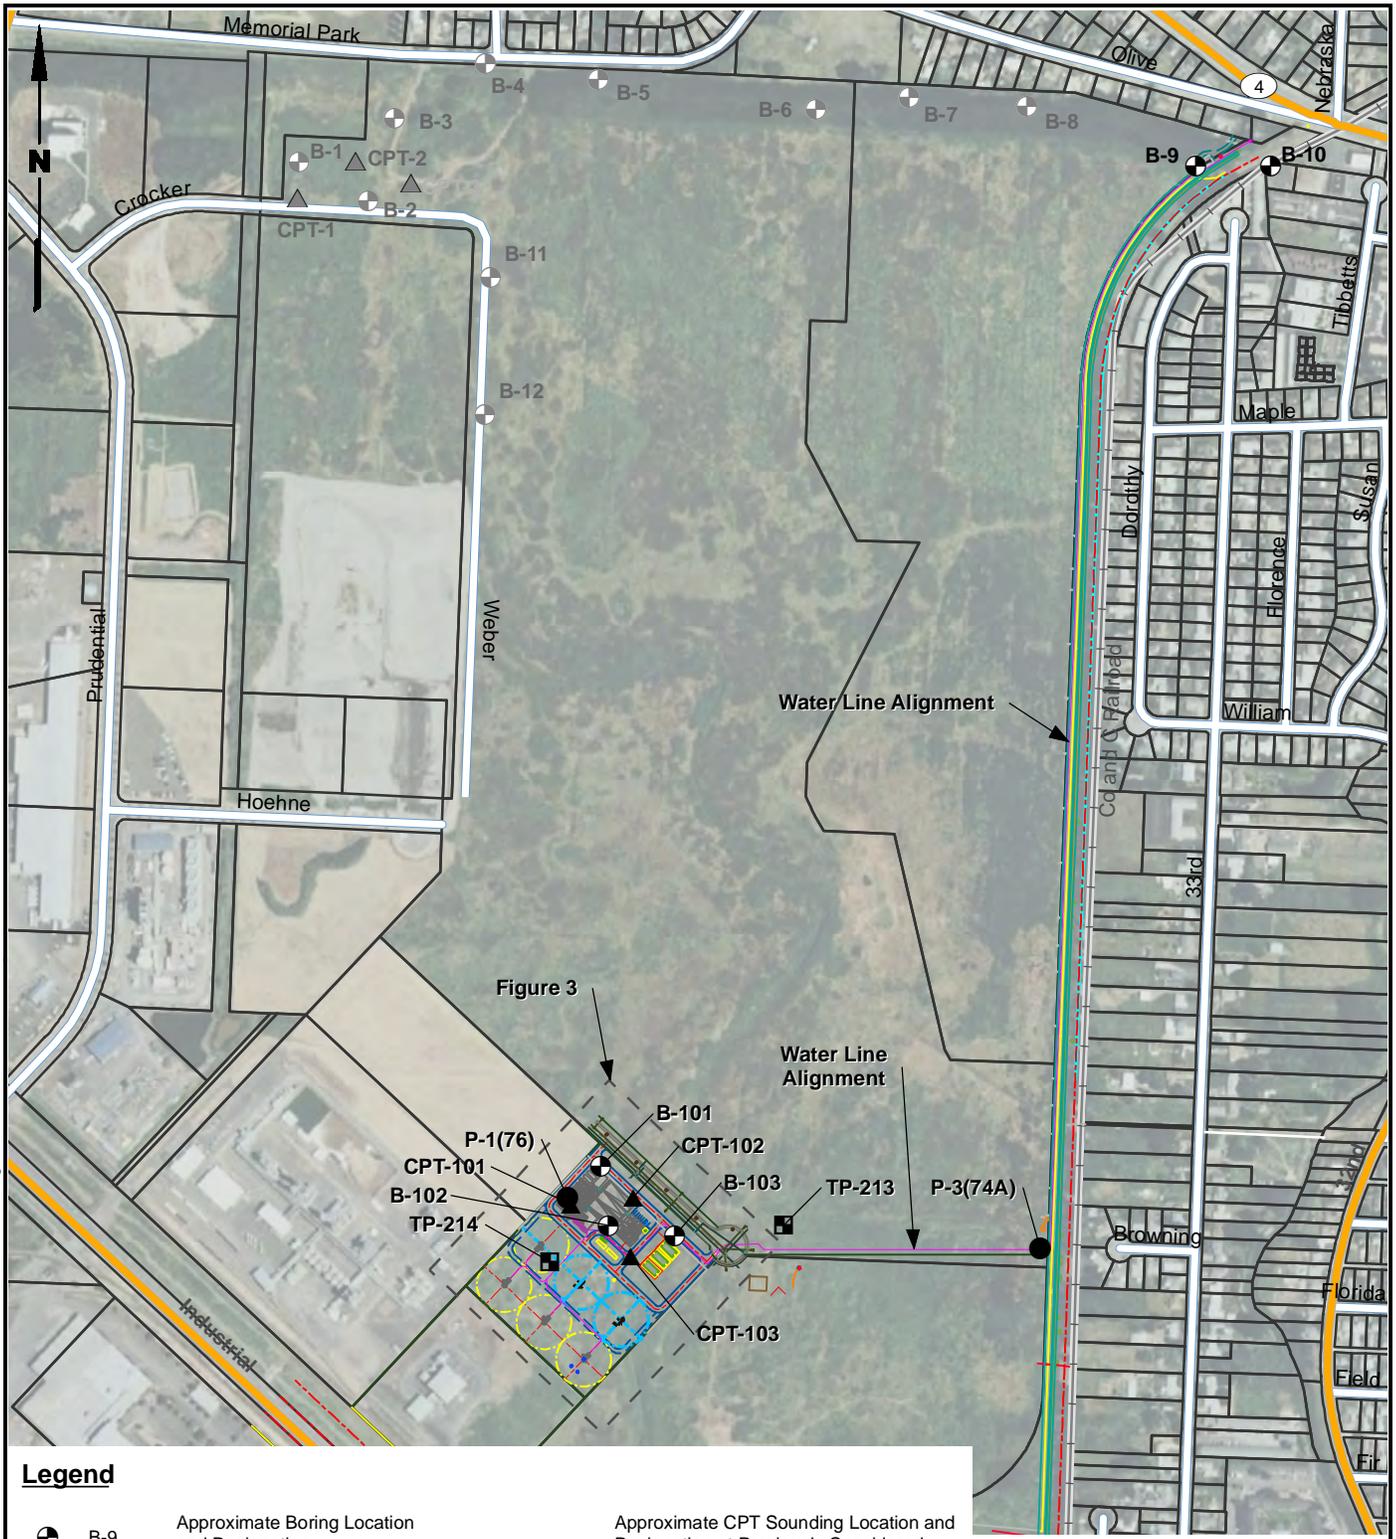
Figure
 2

Site and Exploration Plan

Subsurface conditions at the location of the proposed Longview Regional Water Treatment Plant (Longview RWTP) and waterline route were explored on May 8, 2009 and between August 12 and 18, 2009. The exploration program consisted of advancing five (5) exploratory borings (B-9, B-10, and B-101 through B-103) and three (3) cone penetrometer test (CPT) soundings (CPT-101 through CPT-103) at the approximate locations illustrated on the Site and Exploration Plan (Figures 2 and 3). The explorations were located in the field with a hand-held GPS unit.

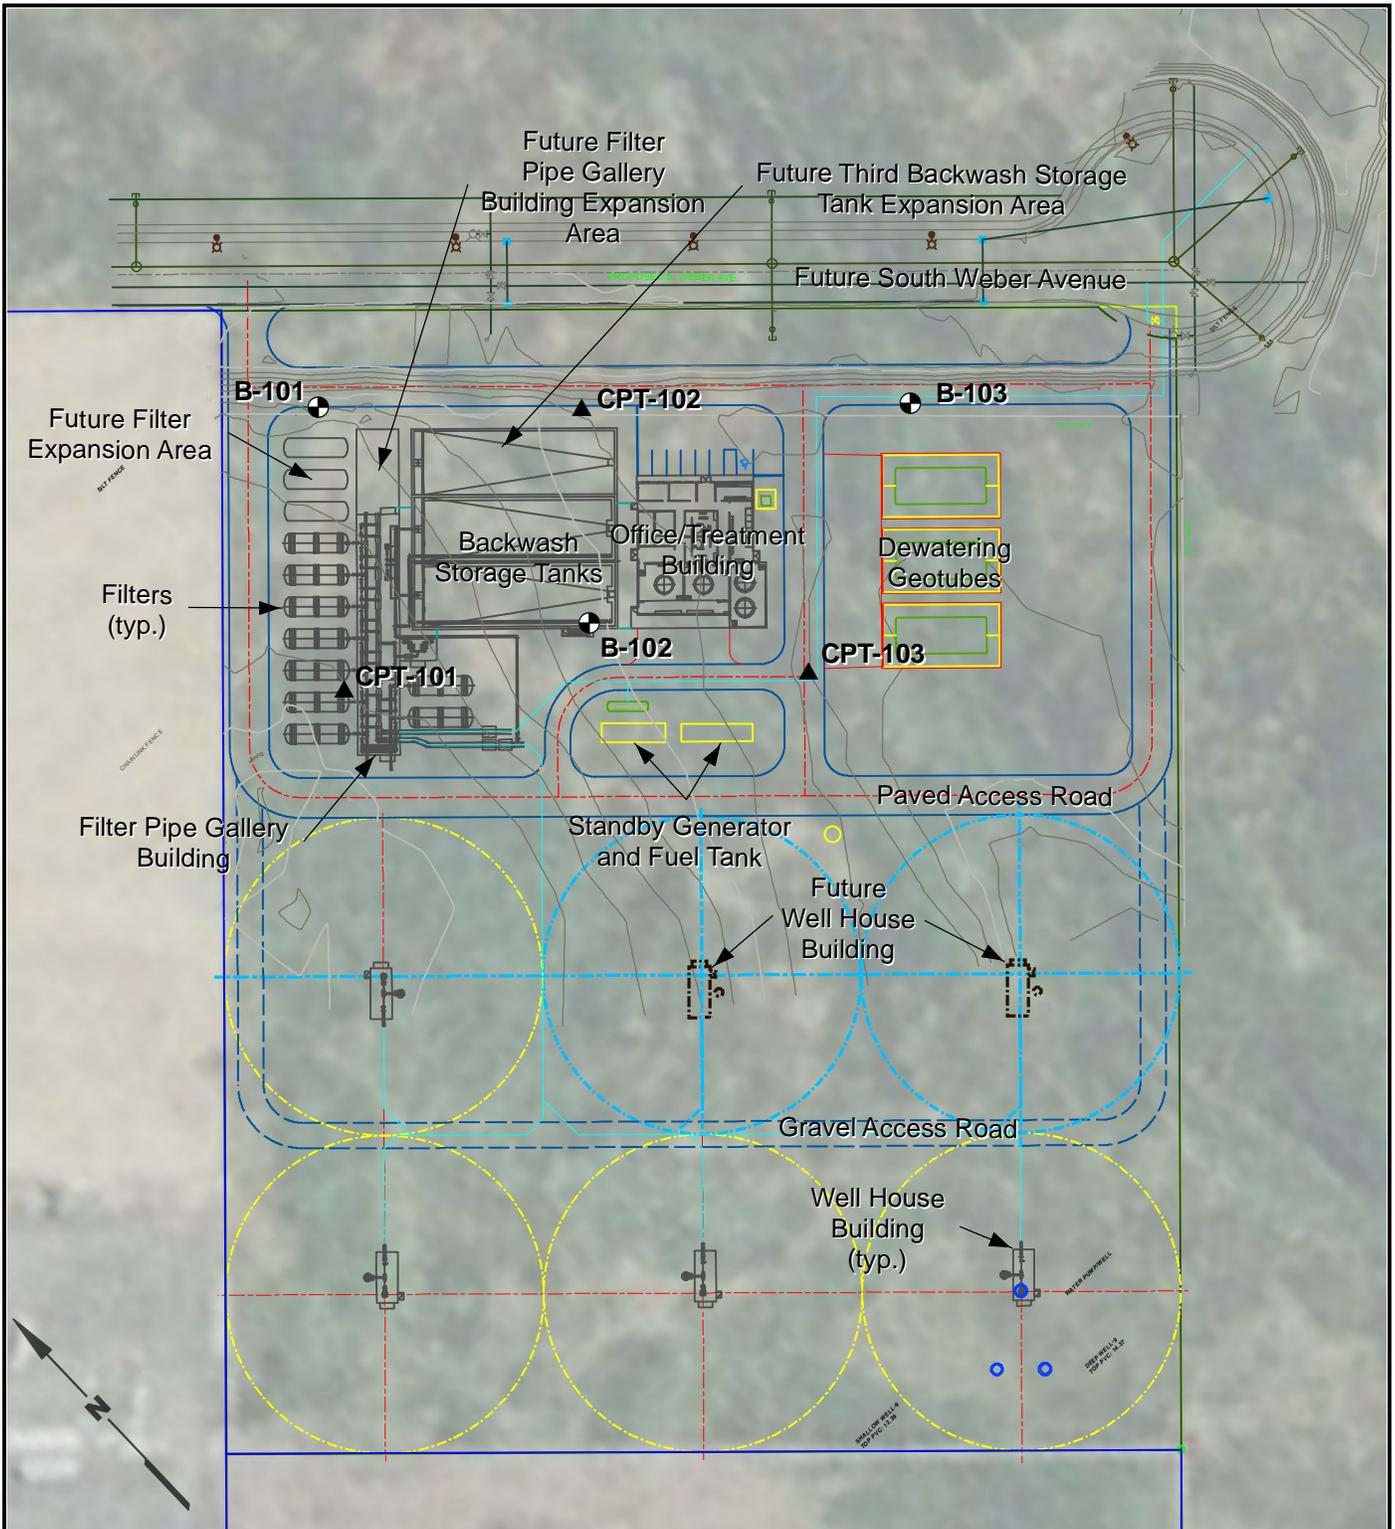
Figure
3

- B-101 Approximate Boring Location and Designation
- ▲ CPT-101 Approximate CPT Sounding Location and Designation

**Site and Exploration Plan -
Water Treatment Plant Site**

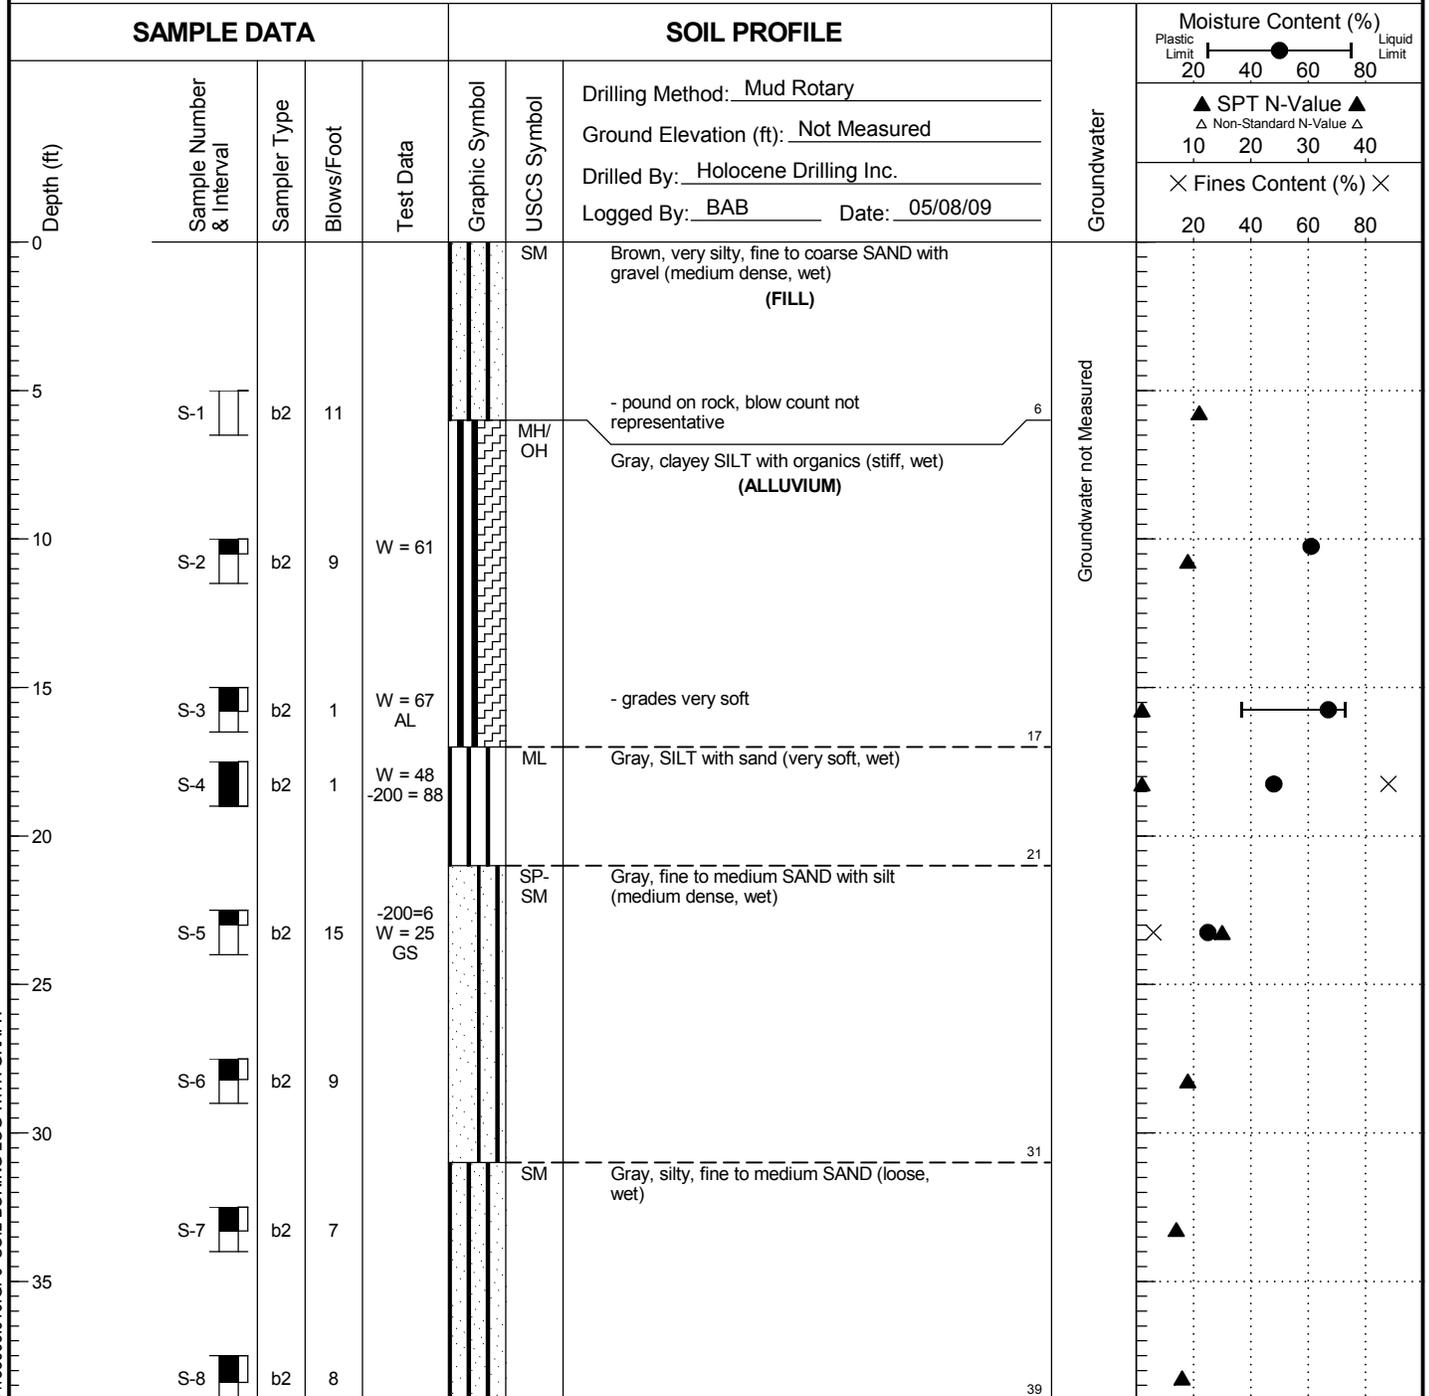
Log of Boring B-10

Boring Completed 05/08/09. Total Depth of Boring = 39.0 ft.

The exploratory borings (B-9, B-10, and B-101 through B-103) were advanced to depths of between 39 and 79 ft BGS with a truck- or track-mounted drill rig and the mud-rotary drilling technique. Borings B-9 and B-10 were advanced on May 8, 2009 while borings B-101 through B-103 were advanced between August 12 and 14, 2009. Holocene Drilling, Inc., of Edgewood, Washington advanced the borings under subcontract to Landau Associates.

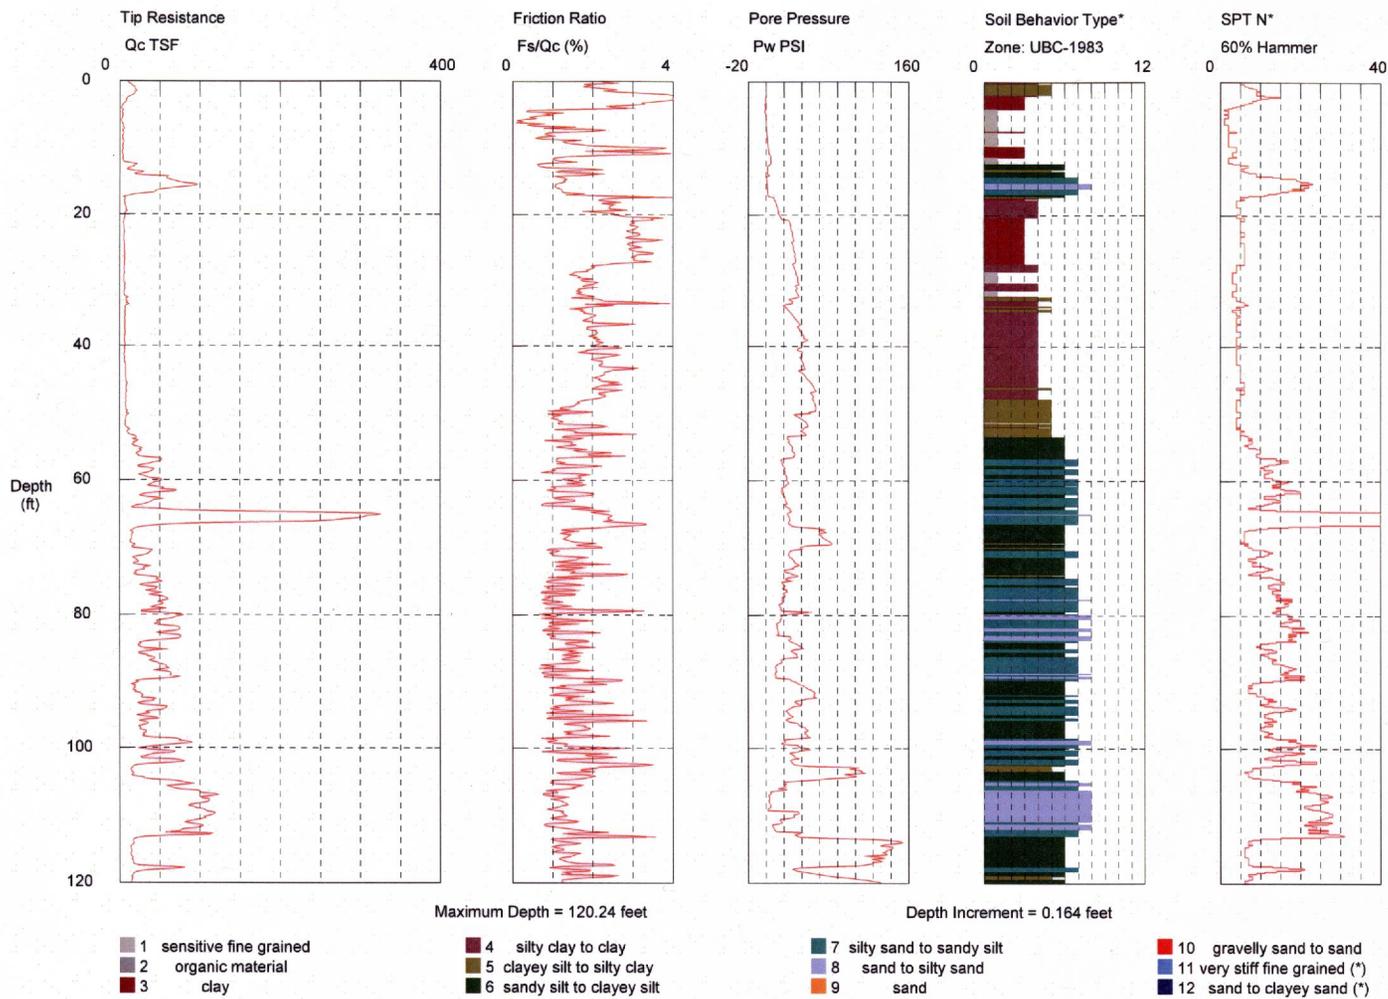
Operator: Dafni
Sounding: CPT-101
Cone Used: DSG1079

CPT Date/Time: 8/18/2009 1:40:18 PM
Location: Longview Water Treatment Plant
Job Number: 133009.010.011

*Soil behavior type and SPT based on data from UBC-1983

At each CPT sound location, a four-channel electronic cone was pushed at a rate of about 1 to 2 cm/sec. The cone was used to simultaneously record tip resistance, sleeve friction, pore pressure, and inclination every 5 cm. Data was transmitted electronically from the cone to a receiver located at the ground surface. Upon completion of testing, the CPT soundings were abandoned in general accordance with the requirements of WAC 173-160.

In Situ Engineering, Inc. reduced the collected CPT data and plotted tip resistance and friction ratio (sleeve friction divided by tip resistance) as a function of sounding depth. They then used published correlations (Robertson and Campanella 1983) to estimate soil behavior types and equivalent Standard Penetration Test (SPT) values at each interval where data was recorded (i.e., every 5 cm). In Situ Engineering's detailed interpretation of soil behavior types and equivalent SPT values are presented on Figures A-7 through A-9. Text files of the CPT test results are also included on a compact disk (CD) on included in Appendix A.

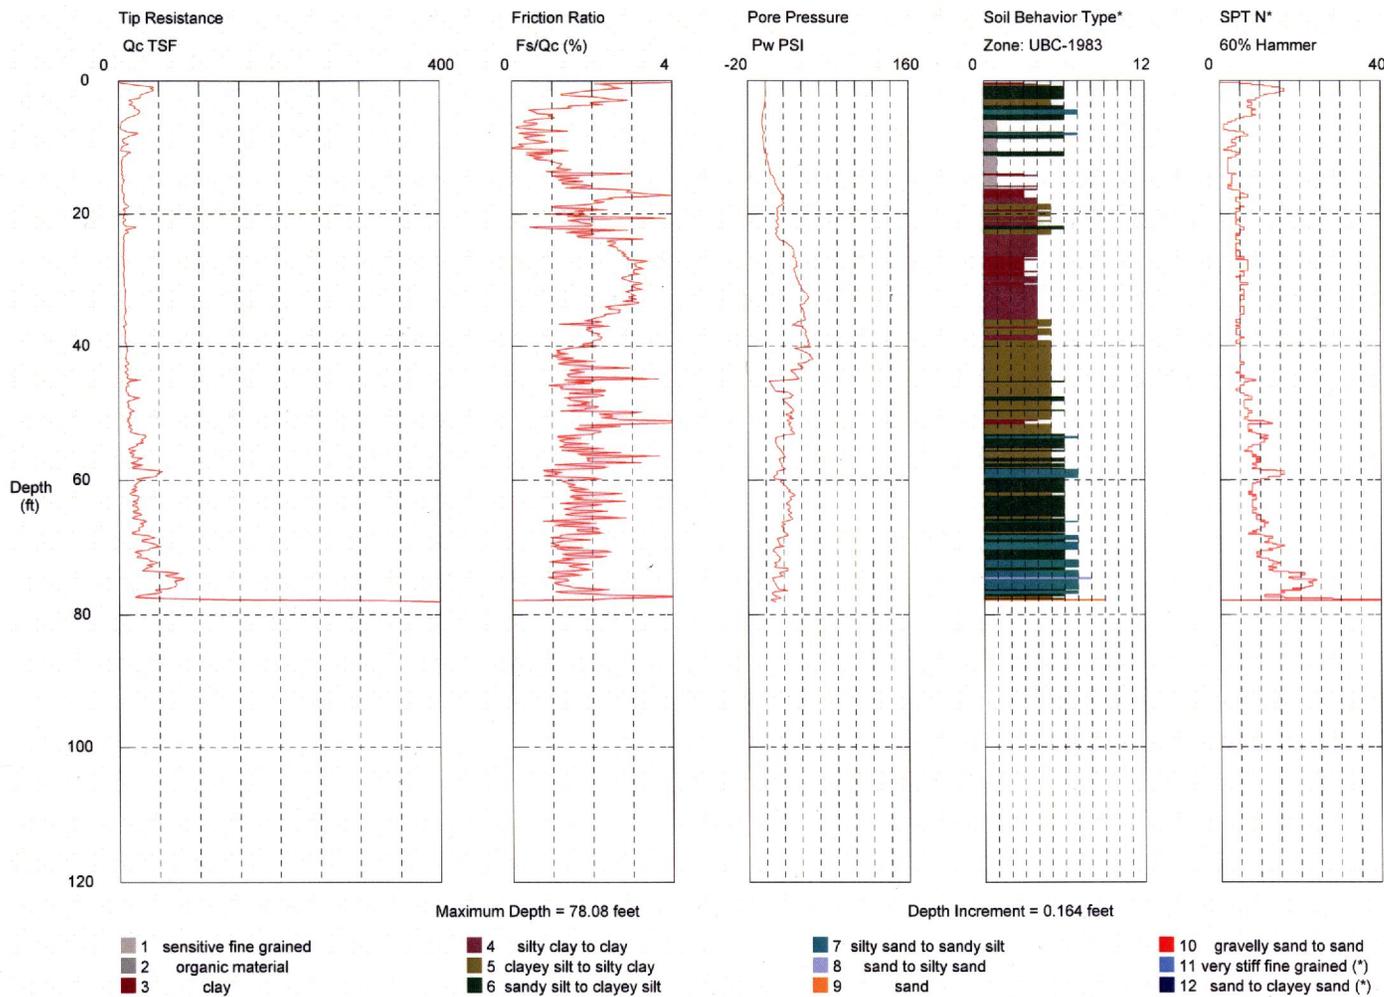
Operator: Dafni
Sounding: CPT-102
Cone Used: DSG1079

CPT Date/Time: 8/18/2009 11:30:03 AM
Location: Longview Water Treatment Plant
Job Number: 133009.010.011

*Soil behavior type and SPT based on data from UBC-1983

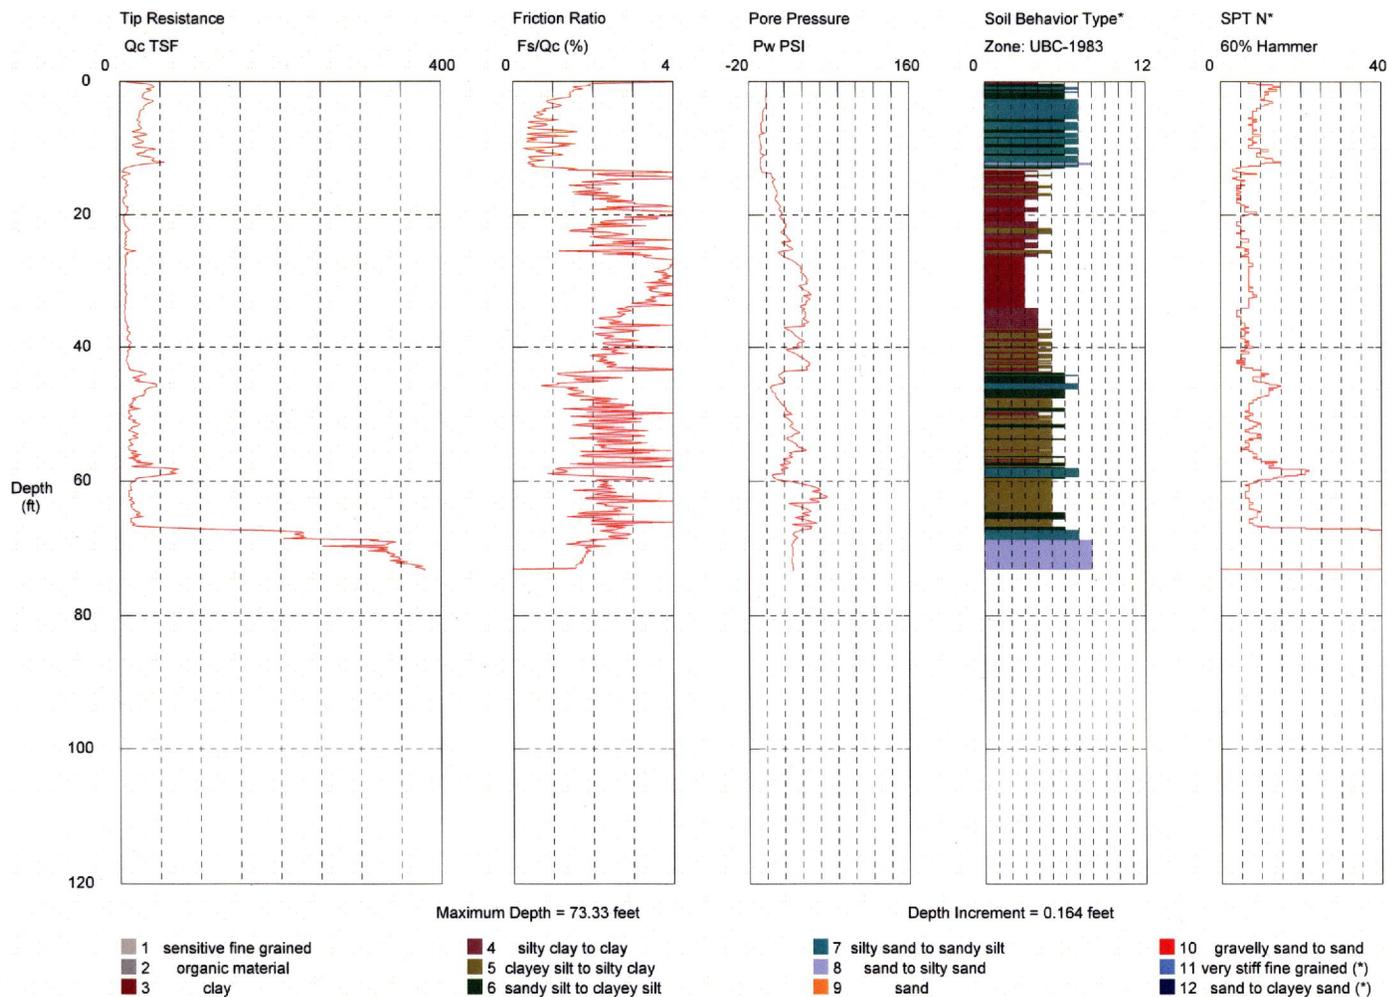
Operator: Dafni
Sounding: CPT-103
Cone Used: DSG1079

CPT Date/Time: 8/17/2009 1:54:39 PM
Location: Longview Water Treatment Plant
Job Number: 133009.010.011

*Soil behavior type and SPT based on data from UBC-1983

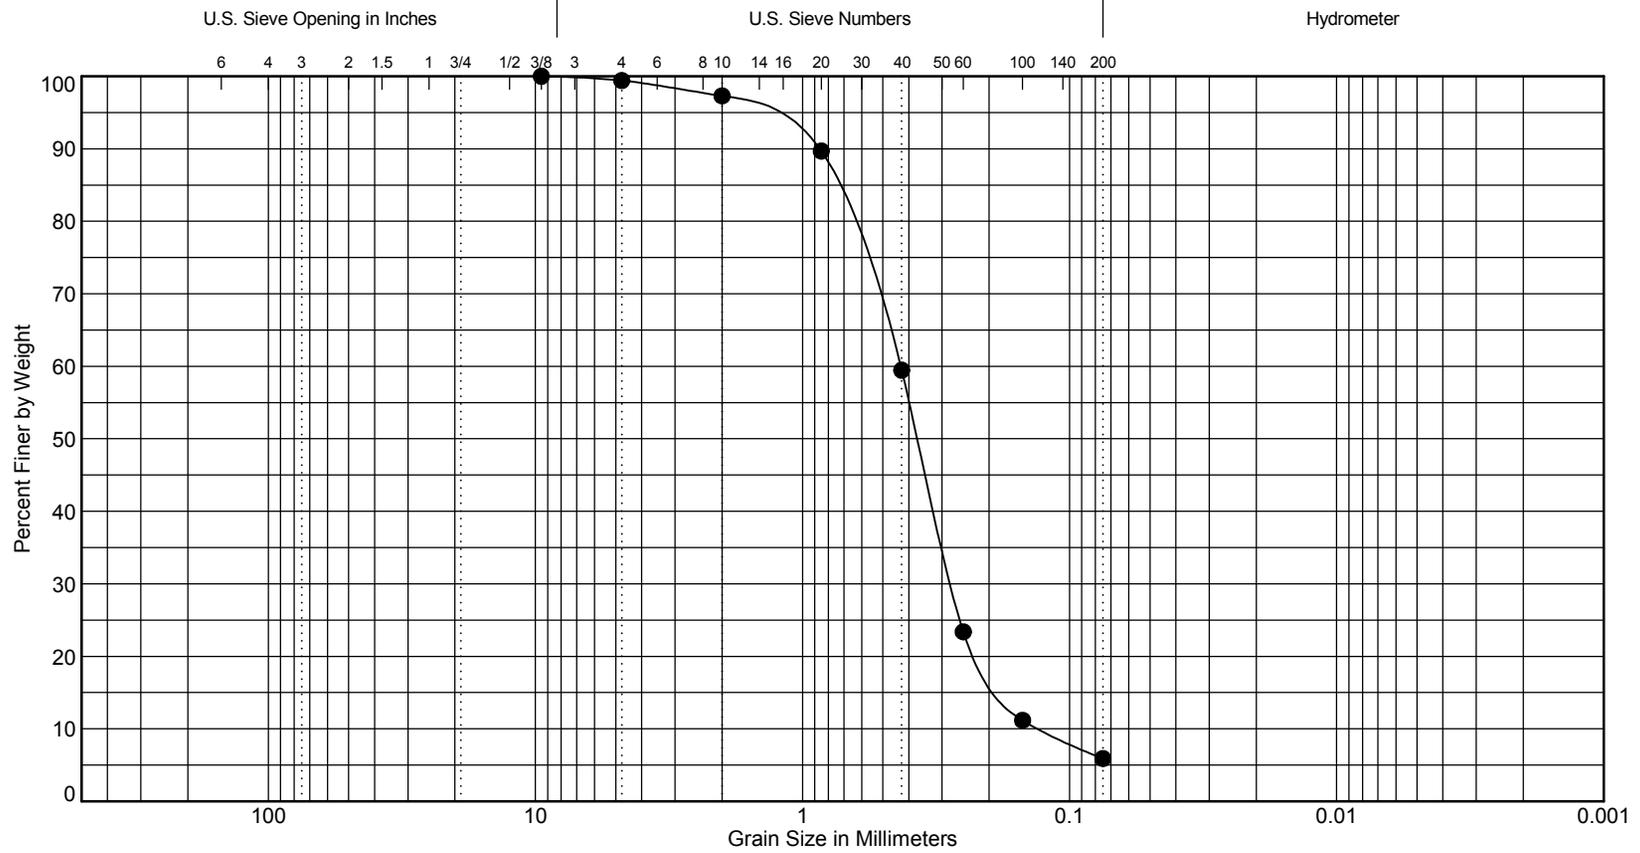
Symbol	Exploration Number	Sample Number	Depth (ft)	Natural Moisture (%)	Soil Description	Unified Soil Classification
●	B-10	S-5	22.5	25	Fine to medium SAND with silt	SP-SM

A grain size analyses was performed on a single soil sample obtained from borings B-10 in accordance with ASTM D422 to provide an indication of the grain size distribution. The sample selected for grain size analysis is designated with a “GS” entry in the column labeled “Test Data” on Figure A-3 in Appendix A. The result of the grain size analysis is presented on Figure B-1 in the form of grain size distribution curve.

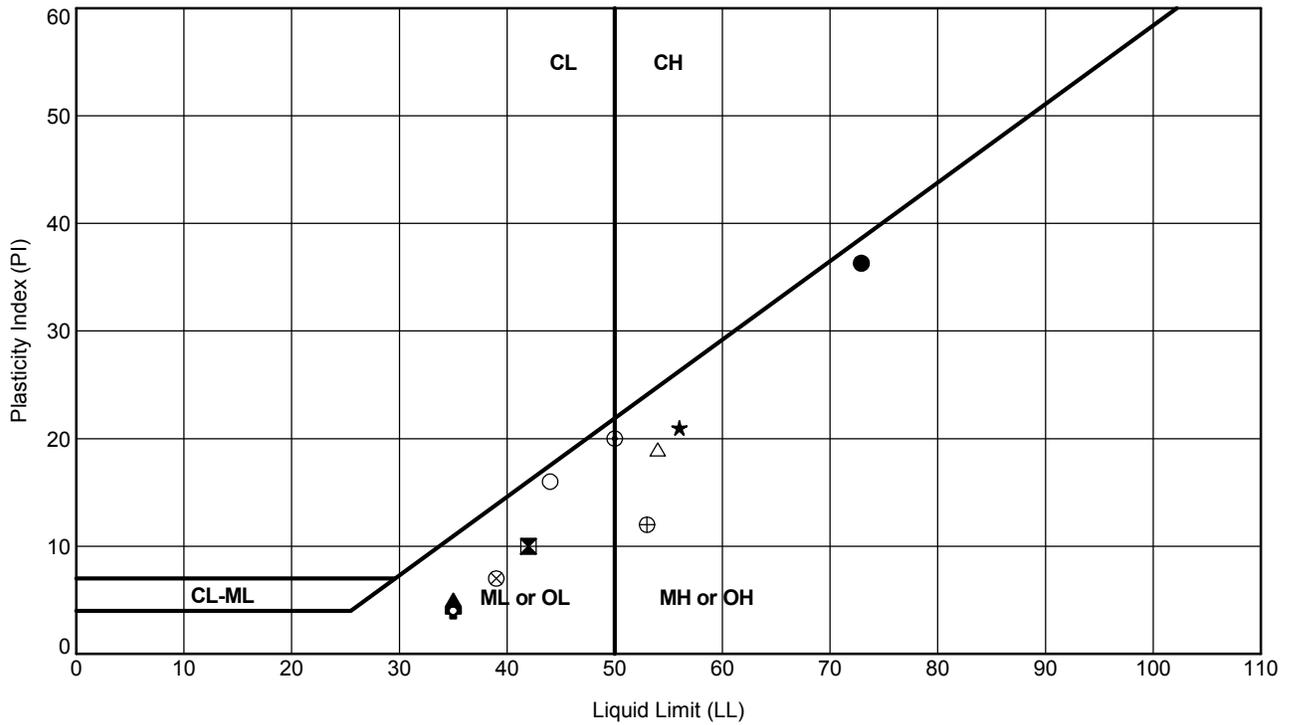
Figure
B-2

ATTERBERG LIMIT TEST RESULTS

Symbol	Exploration Number	Sample Number	Depth (ft)	Liquid Limit (%)	Plastic Limit (%)	Plasticity Index (%)	Natural Moisture (%)	Soil Description	Unified Soil Classification
●	B-10	S-3	15.0	73	37	36	67	Clayey SILT with organics	OH
⊠	B-101	S-2	7.5	42	32	10	49	SILT with organics	ML
▲	B-101	S-4	15.0	35	30	5	37	SILT with trace sand, organics, and wood	ML
★	B-101	S-6	22.5	56	35	21	60	Clayey SILT with scattered fine organics	MH
⊙	B-101	S-8	30.0	50	30	20	51	Clayey SILT with scattered fine organics	MH
⊕	B-102	S-3	12.5	35	31	4	50	SILT with organics and roots	ML
○	B-102	S-6	22.5	44	28	16	50	Clayey SILT with organics and roots	ML
△	B-102	S-9	35.0	54	35	19	55	Clayey SILT with organics and roots	MH
⊗	B-102	S-15	62.5	39	32	7	46	Clayey SILT with fine organics	ML
⊕	B-102	S-18	72.5	53	41	12	52	Clayey SILT with scattered fine organics	MH

Atterberg limit determinations were performed on representative soil samples obtained from the borings in general accordance with ASTM D4318 to determine the liquid limit (LL), plastic limit (PL), and plasticity index (PI). The results of the Atterberg limit determinations are presented on Figures B-2 and B-3. Samples in which Atterberg limit determinations were completed are designated by “AL” in the column labeled “Test Data” in Appendix A and are also shown graphically on the summary boring logs in Appendix A.

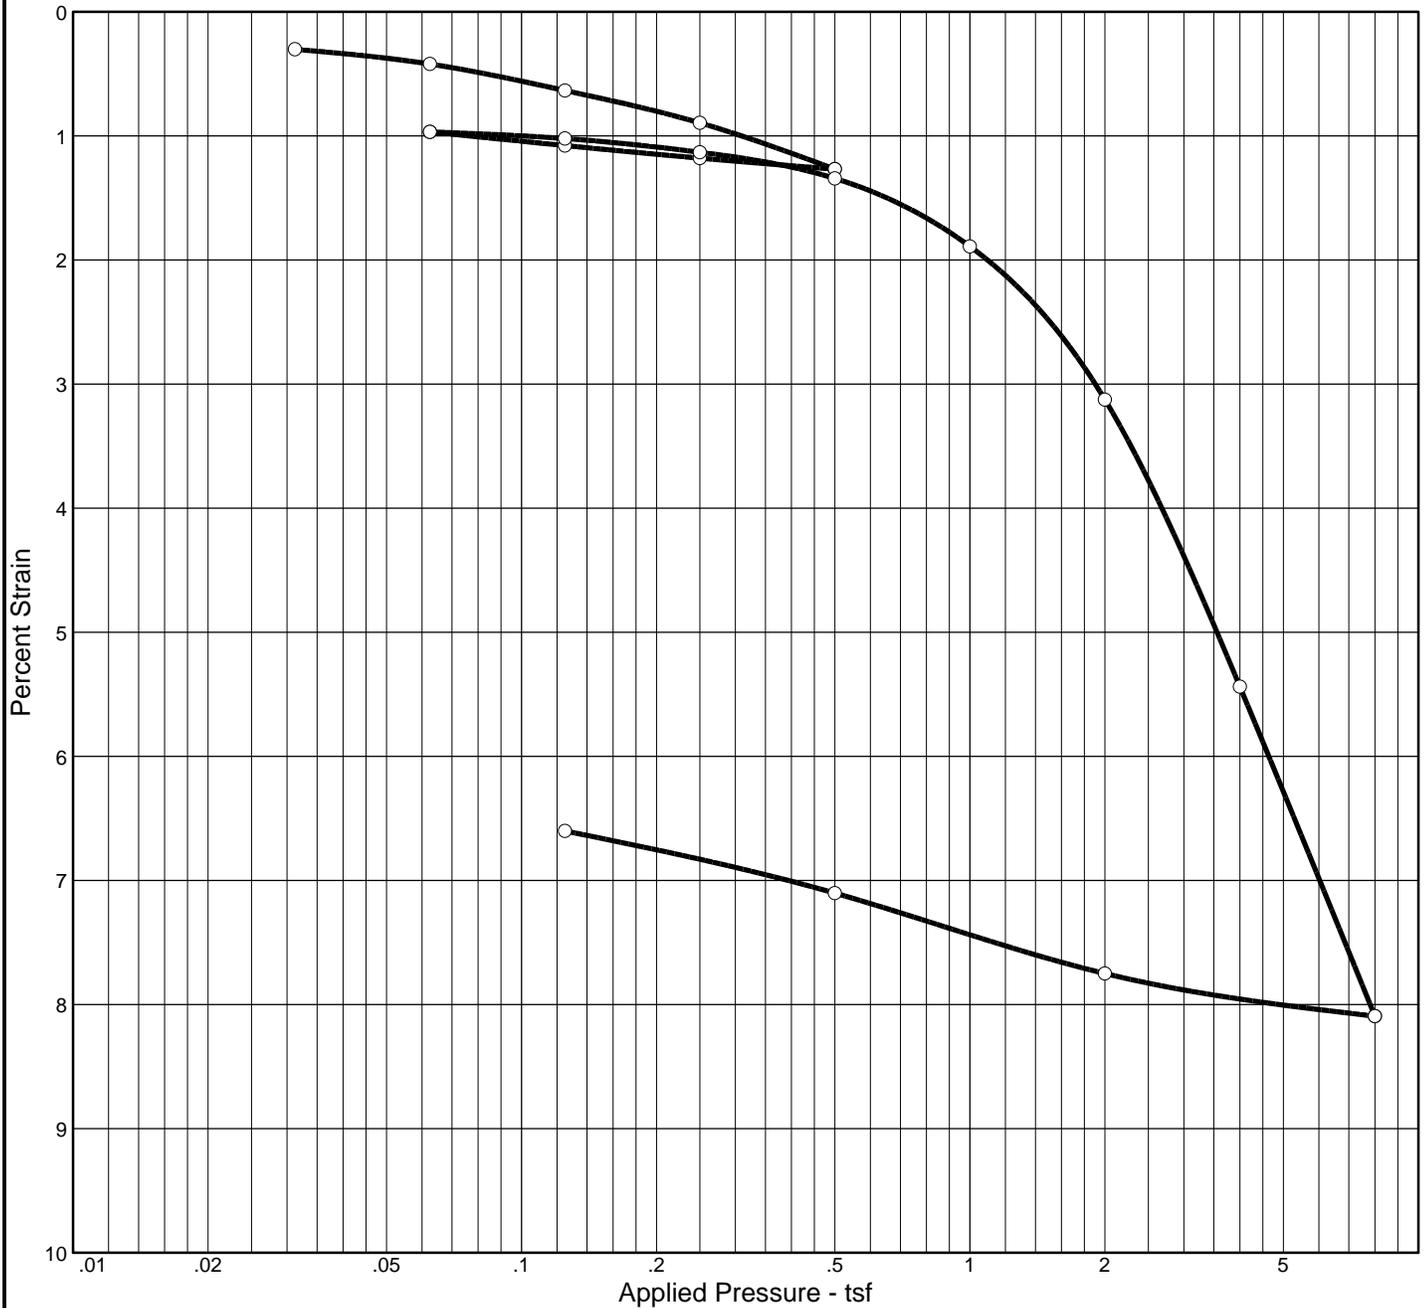
CONSOLIDATION TEST REPORT

Natural		Dry Dens. (pcf)	LL	PI	Sp. Gr.	Overburden (tsf)	P _c (tsf)	C _c	C _r	Swell Press. (tsf)	Swell %	e ₀
Sat.	Moist.											
99.1 %	37.4 %	82.0	35	5	2.60		1.75	0.18	0.01			0.982

MATERIAL DESCRIPTION	USCS	AASHTO
M-stiff, moist, grey SILT	ML	---

The consolidation characteristics of selected fine-grained soil samples obtained from the exploratory borings were determined at Soil Technology, Inc. laboratory in general accordance with ASTM D2435 test procedures. The consolidation test results are included in the Soil Technology reports, which are included in Appendix B. Samples for which this test was completed are designated by “GT” in the column labeled “Test Data” on the summary logs.

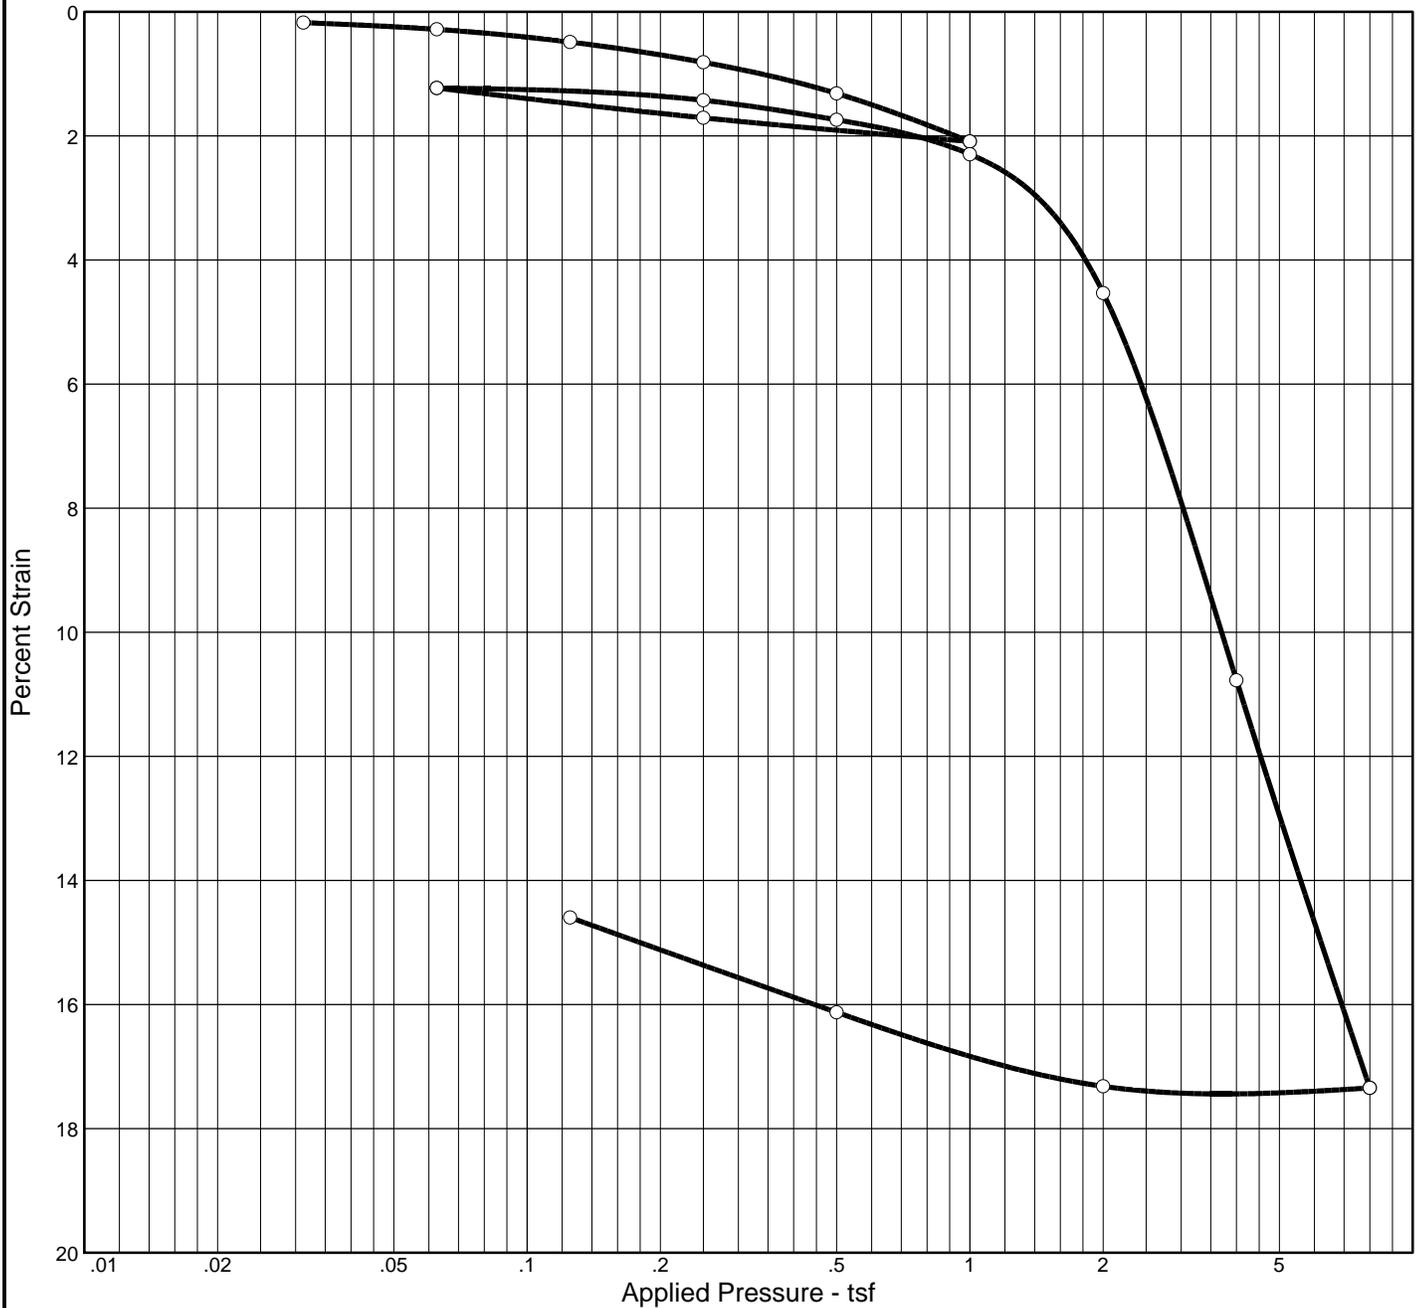
CONSOLIDATION TEST REPORT

Natural		Dry Dens. (pcf)	LL	PI	Sp. Gr.	Overburden (tsf)	P _c (tsf)	C _c	C _r	Swell Press. (tsf)	Swell %	e ₀
Sat.	Moist.											
99.8 %	55.0 %	67.9	54	19	2.7		1.72	0.54	0.03			1.487

MATERIAL DESCRIPTION	USCS	AASHTO
M-stiff, moist, grey SILT	MH	----

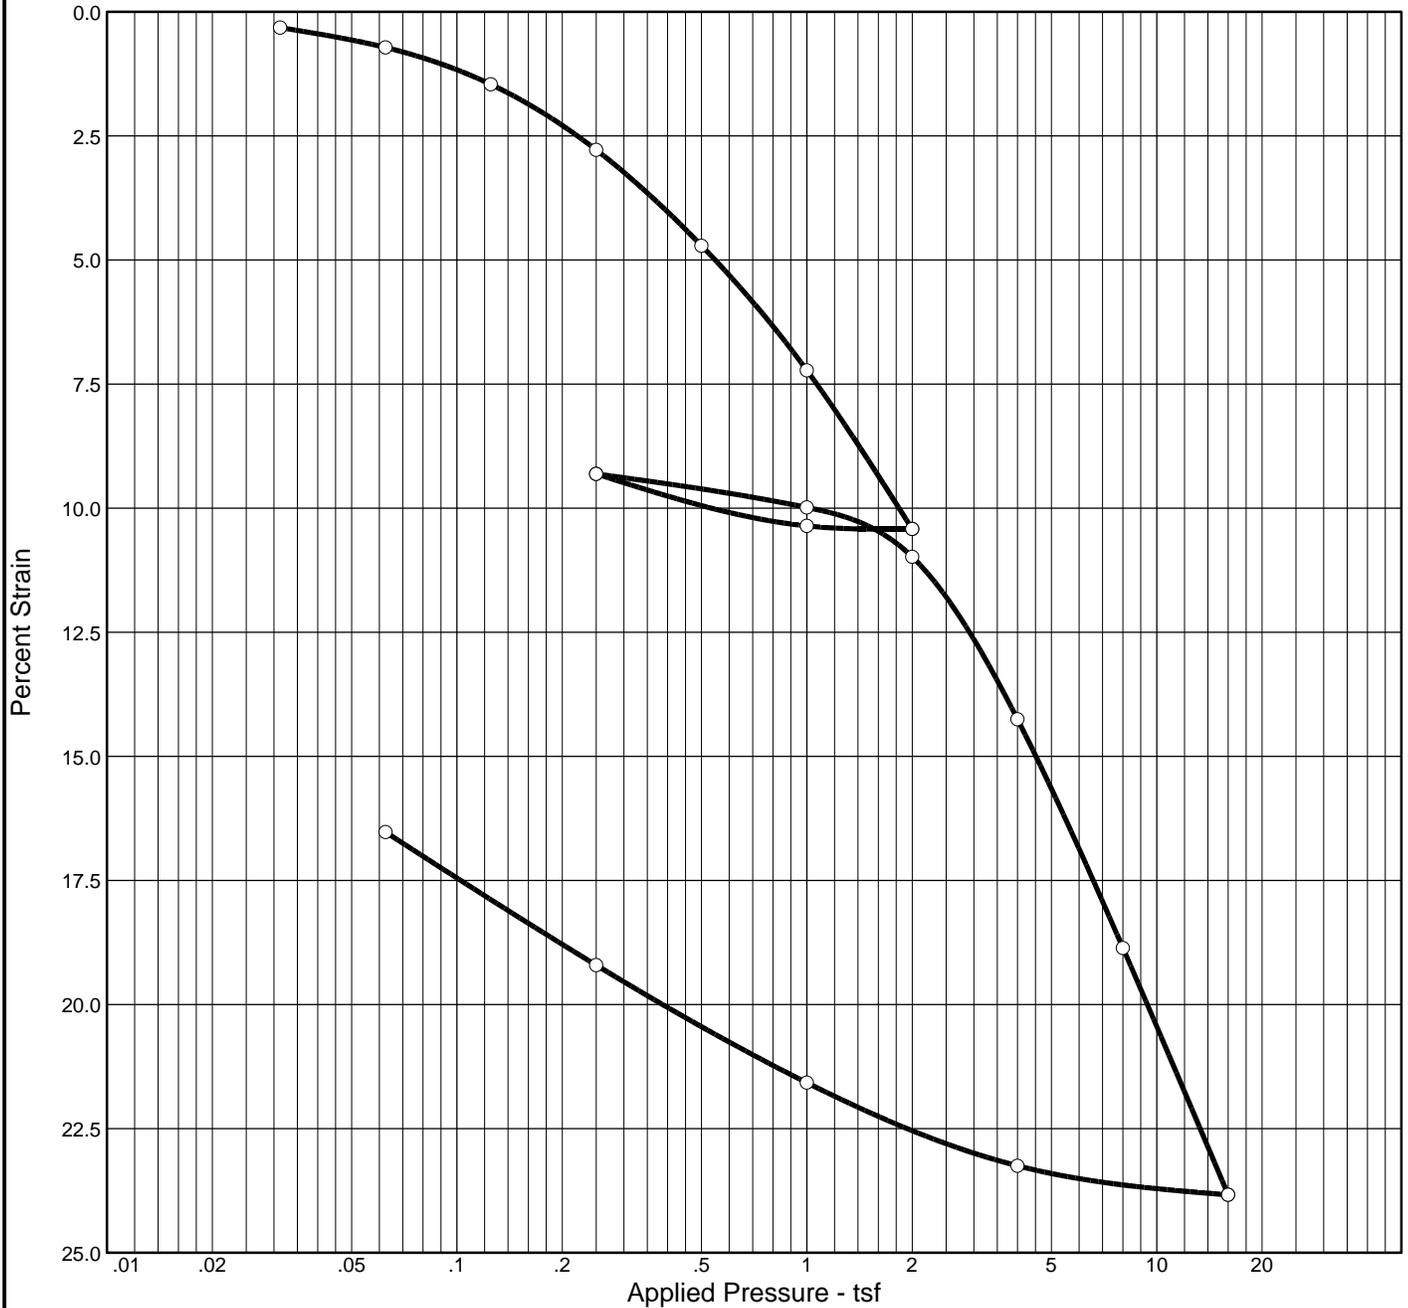
CONSOLIDATION TEST REPORT

Natural		Dry Dens. (pcf)	LL	PI	Sp. Gr.	Overburden (tsf)	P _c (tsf)	C _c	C _r	Swell Press. (tsf)	Swell %	e ₀
Sat.	Moist.											
98.5 %	51.7 %	67.6	53	12	2.5		1.63	0.38	0.05			1.313

MATERIAL DESCRIPTION	USCS	AASHTO
M-Stiff, moist, grey SILT w/ organics	MH	----

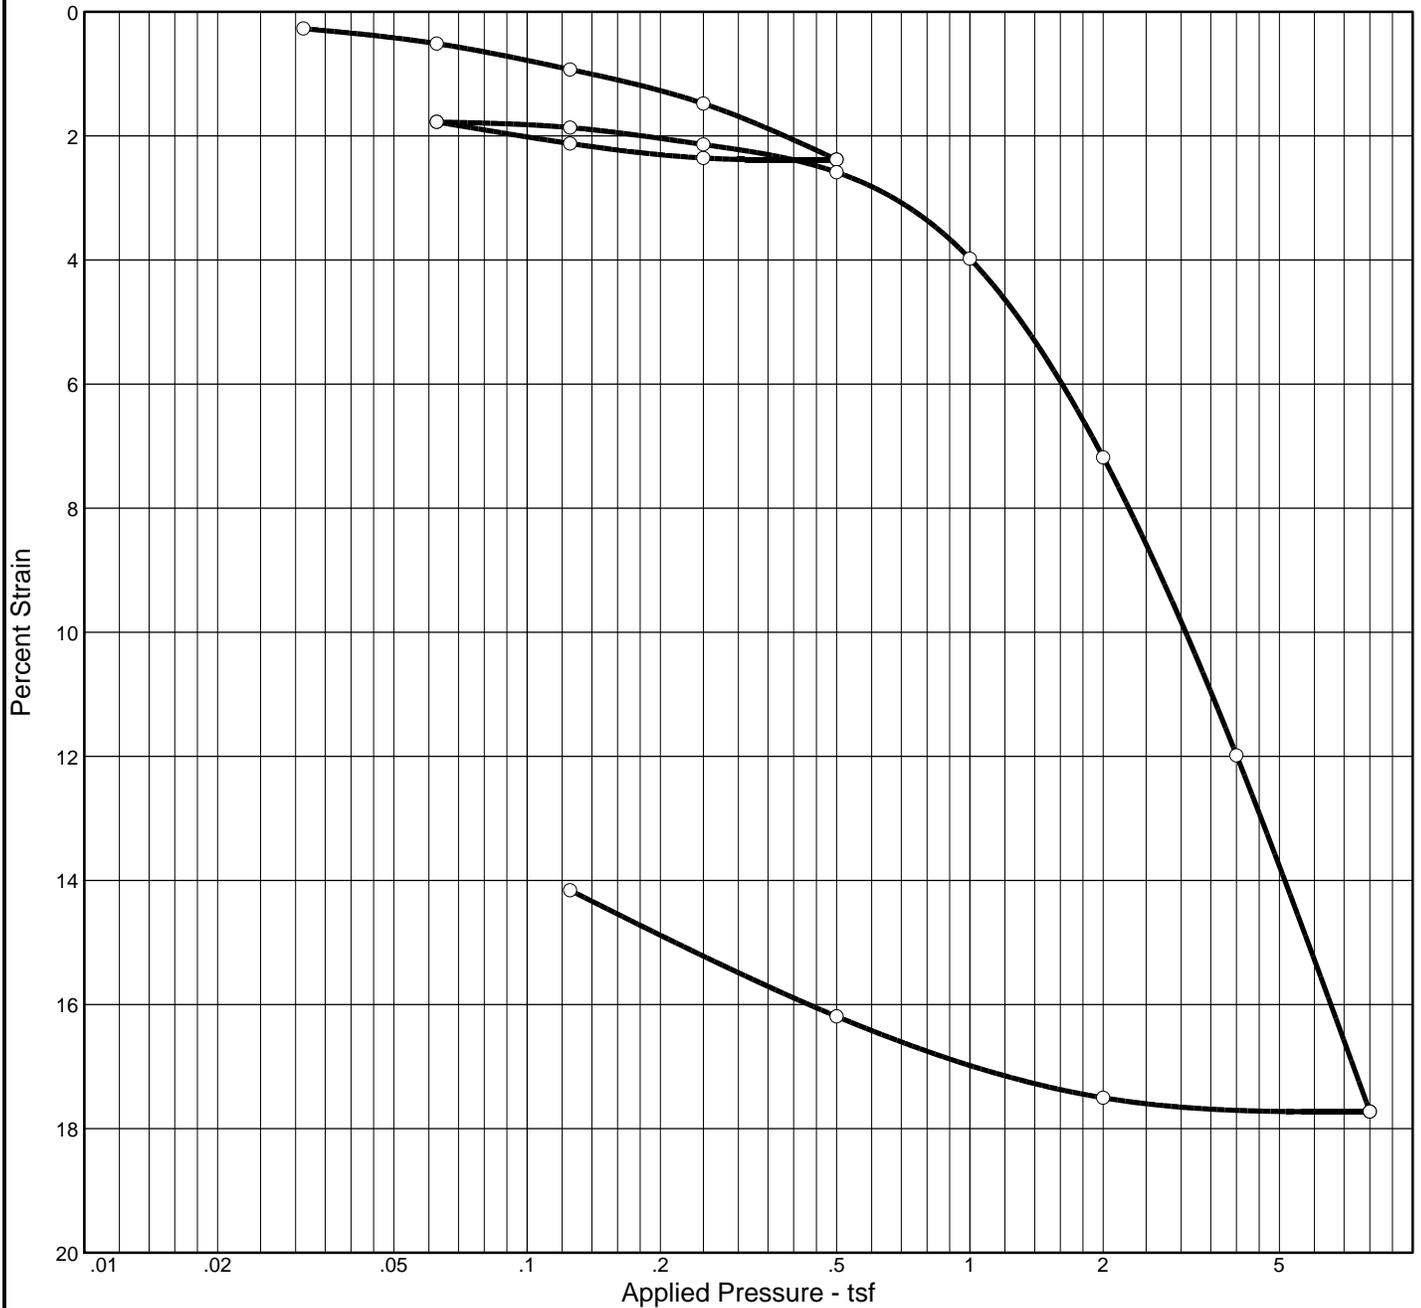
CONSOLIDATION TEST REPORT

Natural		Dry Dens. (pcf)	LL	PI	Sp. Gr.	Overburden (tsf)	P _c (tsf)	C _c	C _r	Swell Press. (tsf)	Swell %	e ₀
Sat.	Moist.											
100.0 %	63.4 %	61.8	67	24	2.65		1.73	0.51	0.03			1.680

MATERIAL DESCRIPTION	USCS	AASHTO
M-stiff, moist, grey, organic SILT	OH	----
