Geotechnical Data Report Longview Regional Water Treatment Plant Longview, Washington

June 7, 2010

This Geotechnical Data Report (GDR) presents the results of our field geotechnical investigation and laboratory testing program for the Longview Regional Water Treatment Plant and associated waterline in Longview, Washington. The overall project location is shown on the Vicinity Map, Figure 1. The Site and Exploration Plan, Figure 2, shows the approximate location of the explorations completed for this study as well as the locations of historical borings completed by others along the waterline alignment. Figure 3 presents a Site and Exploration Plan for the Water Treatment Plant Site. Appendix A presents summary logs of conditions observed in the explorations completed for this study. The results of the laboratory testing program are included as Appendix B. Logs of previous explorations completed by others are included in Appendix C.

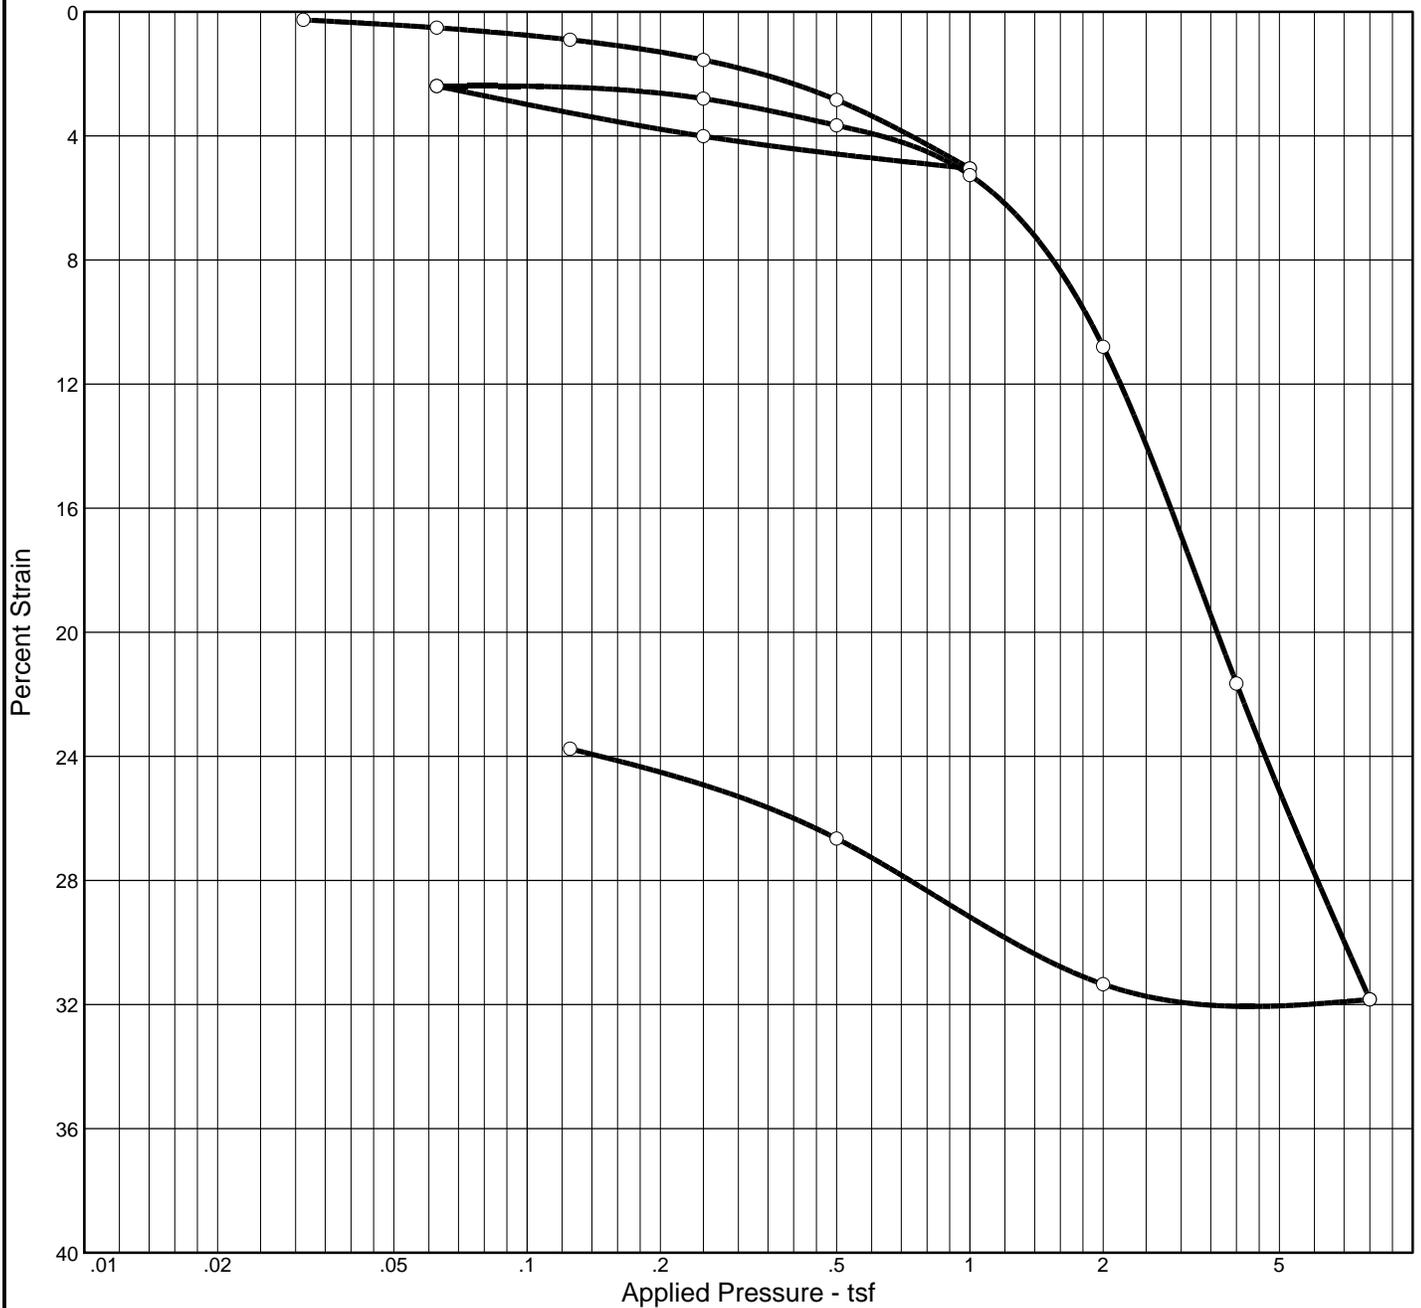
CONSOLIDATION TEST REPORT

Natural		Dry Dens. (pcf)	LL	PI	Sp. Gr.	Overburden (tsf)	P _c (tsf)	C _c	C _r	Swell Press. (tsf)	Swell %	e ₀
Sat.	Moist.											
99.7 %	106.8 %	42.6	131	84	2.55		1.34	1.25	0.12			2.734

MATERIAL DESCRIPTION	USCS	AASHTO
M-stiff, moist, grey-green organic CLAY	OH	---

The consolidation characteristics of selected fine-grained soil samples obtained from the exploratory borings were determined at Soil Technology, Inc. laboratory in general accordance with ASTM D2435 test procedures. The consolidation test results are included in the Soil Technology reports, which are included in Appendix B. Samples for which this test was completed are designated by “GT” in the column labeled “Test Data” on the summary logs.
